Currie & Brown (on behalf of Department of  
Defence)

**Bulimba Barracks**  
**167 Apollo Road, Bulimba**  
**Queensland, 4171**  
*Stage 2 Detailed Site*  
*Investigation*

November 2018

Reference: 0433098

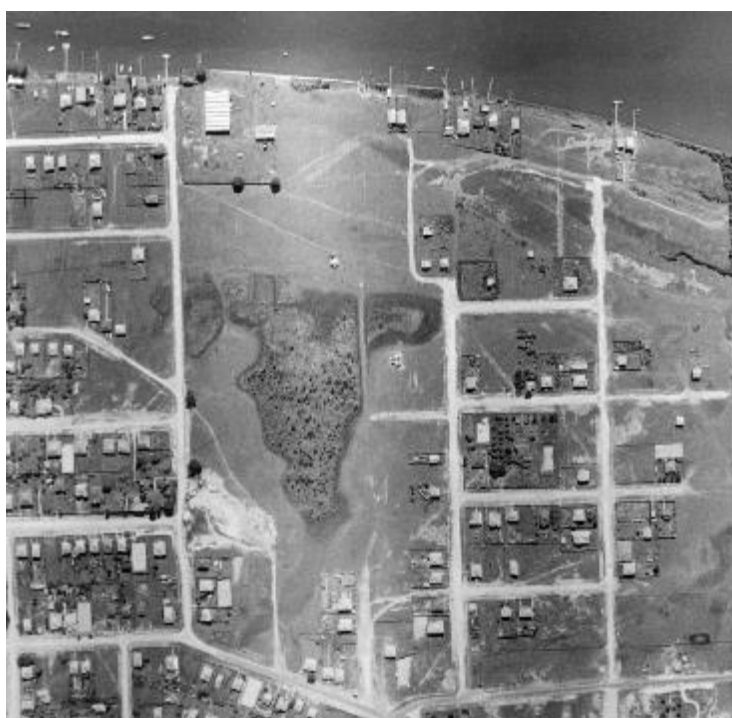
A review of historical photos indicated the presence of a former swamp in the central western portion of the site (refer *Photograph 1*, below).

***Photograph 1 Brisbane 1936 Aerial Photograph Showing Bulimba Barracks Swamp (Source: QImagery, Queensland Government).***

Subsurface conditions encountered in this area were consistent with the historical imagery where high organics and peat materials were observed. Fill materials in this area were present up to a maximum thickness of 1.5mbgs. Refer to *Figures 4a-4b, Annex A*.
