Homewood Ref: 3998

Tuesday, 26 October 2021

**RE: Assessment of trees around the intersection of Deakin Avenue and O'Connor Street, Haberfield**

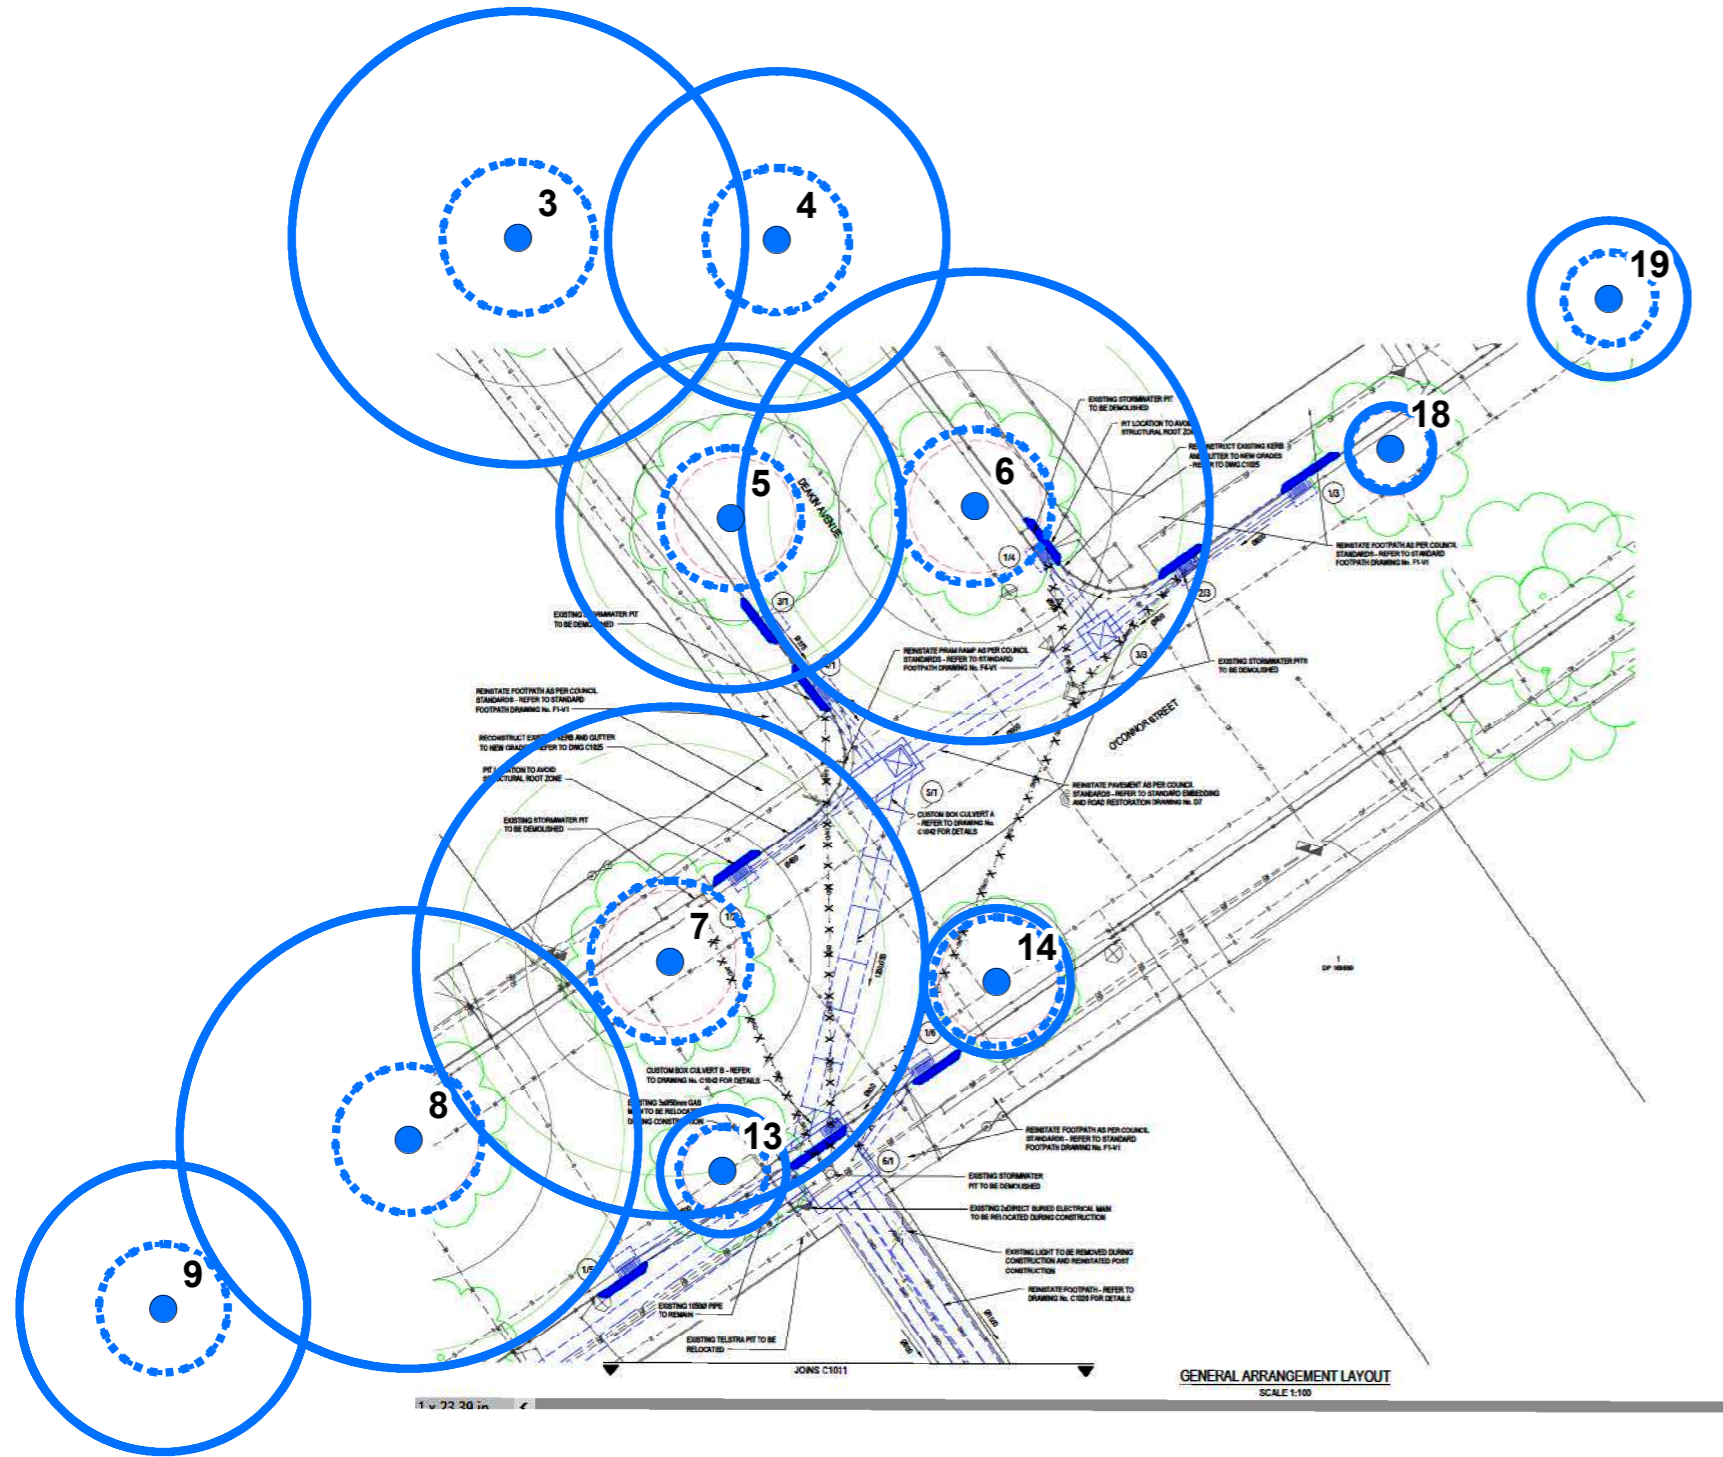
### Tree Protection Plan

One tree (Tree 18- 'Low' retention value) will require removal to facilitate the design. The remaining trees can be retained with the adoption of the tree protection measures outlined below and depicted in the Tree Protection Plan (page 4):

1. TPZ and SRZ dimensions outlined in Table 1 are shown to scale on all Site Plans.
2. Tree protection measures, as outlined in this document, are included in any site induction and all contractors are made aware of these recommended measures prior to commencing work.

3. There is no further excavation or other works undertaken beyond that which is indicated in provided plans.
4. Any works including excavation, installation or demolition/removal of infrastructure within the TPZ of retained trees is conducted under the direct supervision of the Project Arborist (minimum AQF5) and is undertaken as follows:

- 4.4 Exposed tree roots less than 40mm in diameter, may be cleanly pruned by the Project Arborist, at right angles and using sharp, clean tools.
5. Trees 3, 5 and 7 are pruned to obtain 3m vertical clearance over the proposed works area prior to the commencement of works.

6. Trunk protection, as outlined below, is erected around Trees 5-7, 13 and 14.
  - 6.1 Protection may consist of padding surrounding the trunk or branch, held in place with batons strapped together, or similar. Boards are to be strapped to trees, not nailed or screwed.
