21 Construction Squadron Area Gallipoli Barracks Enoggera

Archival Recording

for: Department of Defence

February 2011

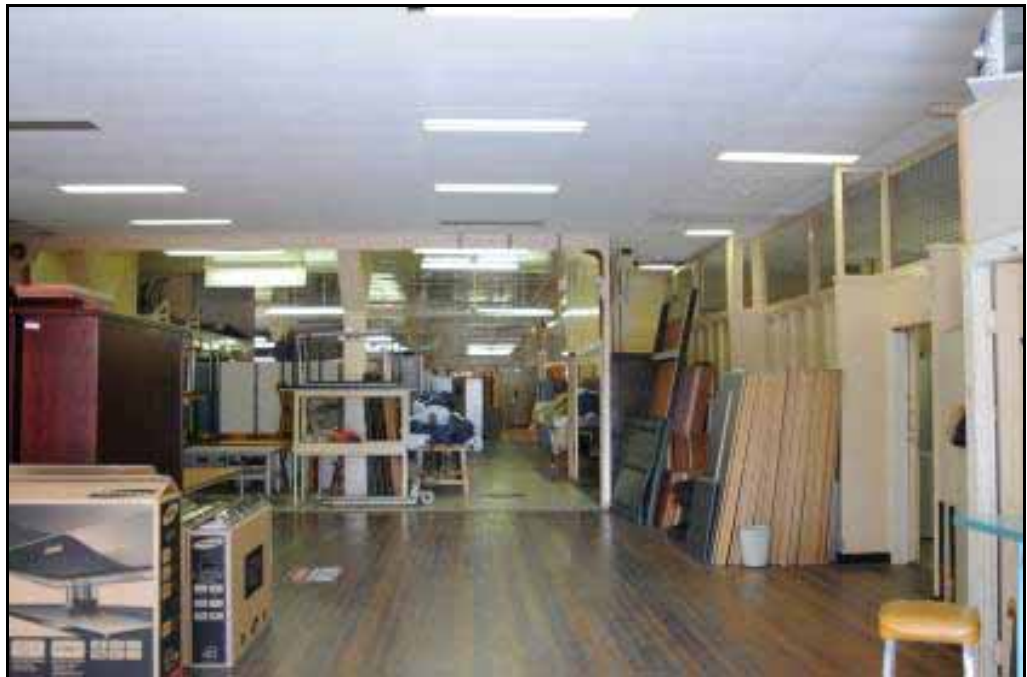
Figure 2.6 Interior Space of C4¹³

The interior retains an original Strong Room located in the north western corner of the building. Masonite clad partitioning has been added presumably at the time the building was occupied by 1 Topographical Survey Squadron.

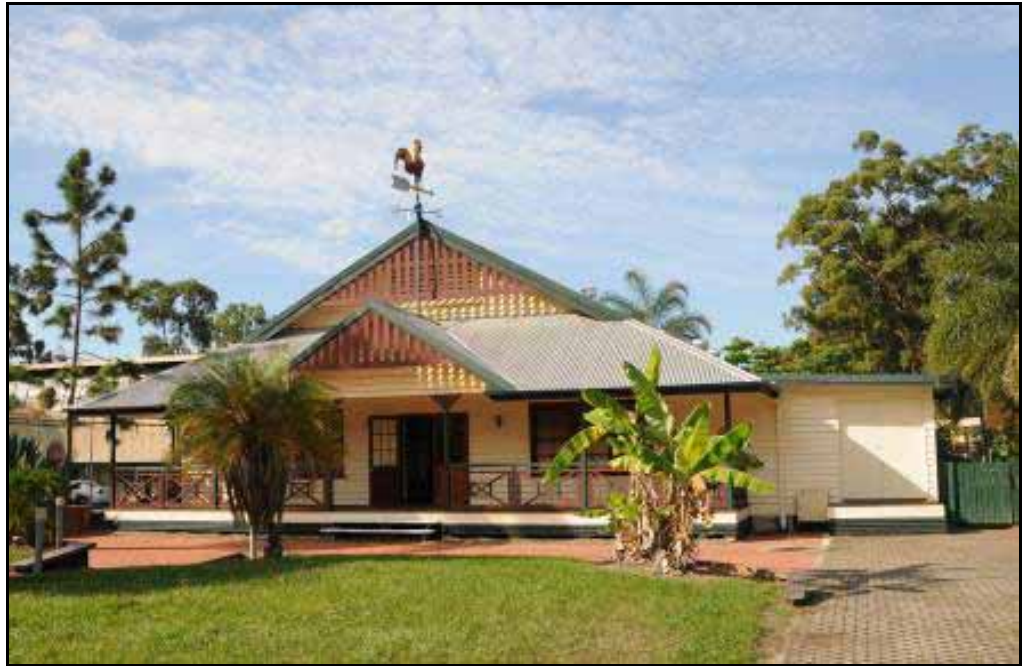
Figure 2.7 Building C45¹⁴

C45 was redeveloped as a mess for 21 Construction Squadron after 1993 when it relocated from Puckapunyal. The building had verandahs with Federation inspired detailing added during this time.

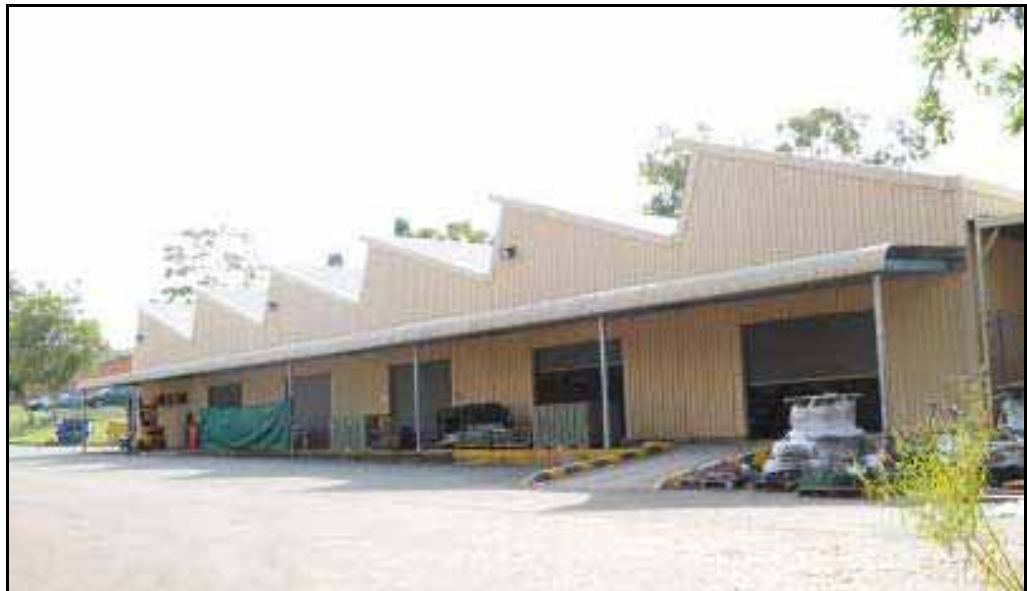
Figure 2.8 *Building C48*¹⁵

This building was constructed to cope with additional stores required due to the increase of soldier numbers, goods and weaponry as a result of the war. Development was slow between the wars and soldier numbers on site waned. With the inception of WWII and increased soldier numbers, strain was placed on existing facilities. The War Cabinet requested the re-use of existing storage and accommodation facilities where possible, in an effort to save money on new construction¹⁶.

This building is the only of its type on site, and appears to be rare in the wider Queensland and Australian context. Margaret Pullar's¹⁷ report indicates that WWII sawtooth roof warehouses were constructed throughout the State, but were primarily timber-framed structures. Building C48's steel framed construction suggests this building is rare, however, following ERM's initial HIA in May 2010 an example with identical construction has been located at the former Gona Barracks in Brisbane. The Queensland Heritage Register entry (601966) indicates a number of new facilities were constructed at Gona Barracks during World War II and "*One was a garage and workshops building for servicing AASC vehicles, made necessary by the Army's process of converting from horse transport to motorised. Plans for the building were prepared in November 1939 and it is thought construction of the building was completed around 1942.*" ERM has also located archival drawings of two bay example of the same type building being constructed at Atherton c1939 as an Equipment Store and Vehicle Shed. This building is no longer extant.

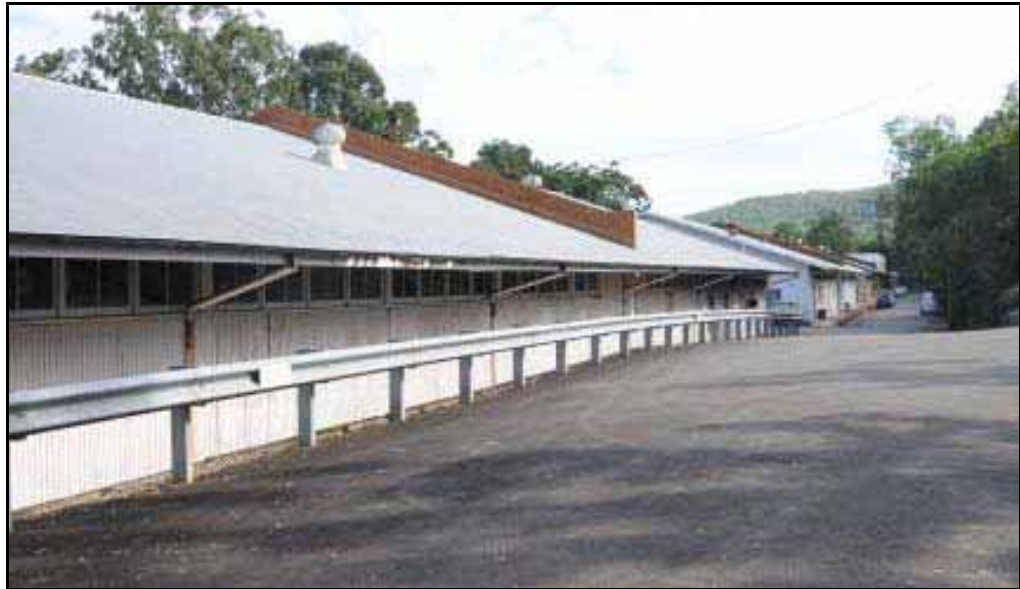
Figure 2.9 Buildings C58, C55 and C49¹⁸

These buildings form a warehouse storage complex located on Secombe Parade and can be dated to 1920 -1925.

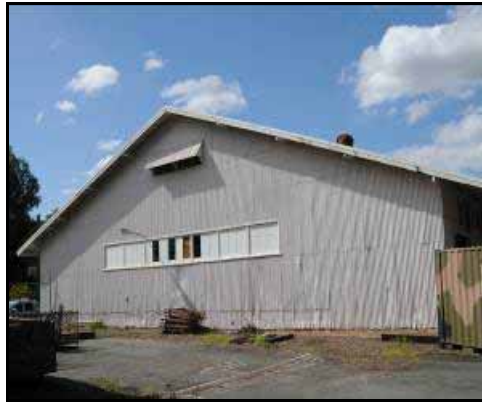
Figure 2.10 Building C55²⁰

C55 is identical in its detailing to C49 and it can be concluded that both buildings were constructed c1920. The differences in the buildings have occurred as a result of changes over time. Like C49 the floor of C55 has been replaced in reinforced concrete. The building retains all high level windows on south and north elevations and original windows and high level timber vents in the gable ends. Like C49 all the original sliding timber doors have been removed but some of the original corrugated iron wall cladding survives. There has been no termite damage to the truss ends.

C55 has higher integrity than C49 and is in better condition.

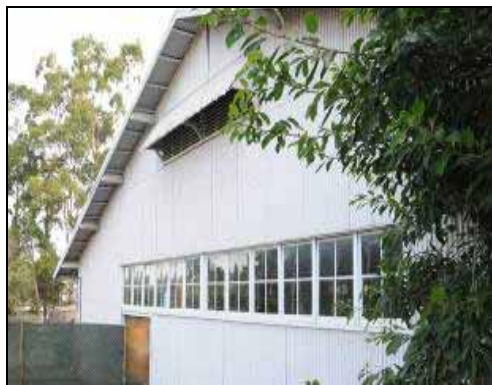
Figure 2.12 Building C58²²

Exactly the same heavy timber construction system was adopted for this building except it was founded on a reinforced concrete floor. There are some subtle construction detailing differences in this later building, these include; differing timber sizes in the roof trusses, bolted angle brackets to each side of the centre post corbel support, modified knee bracket connection to outer timber posts and the introduction of 8" x 4" lateral beam over central posts.

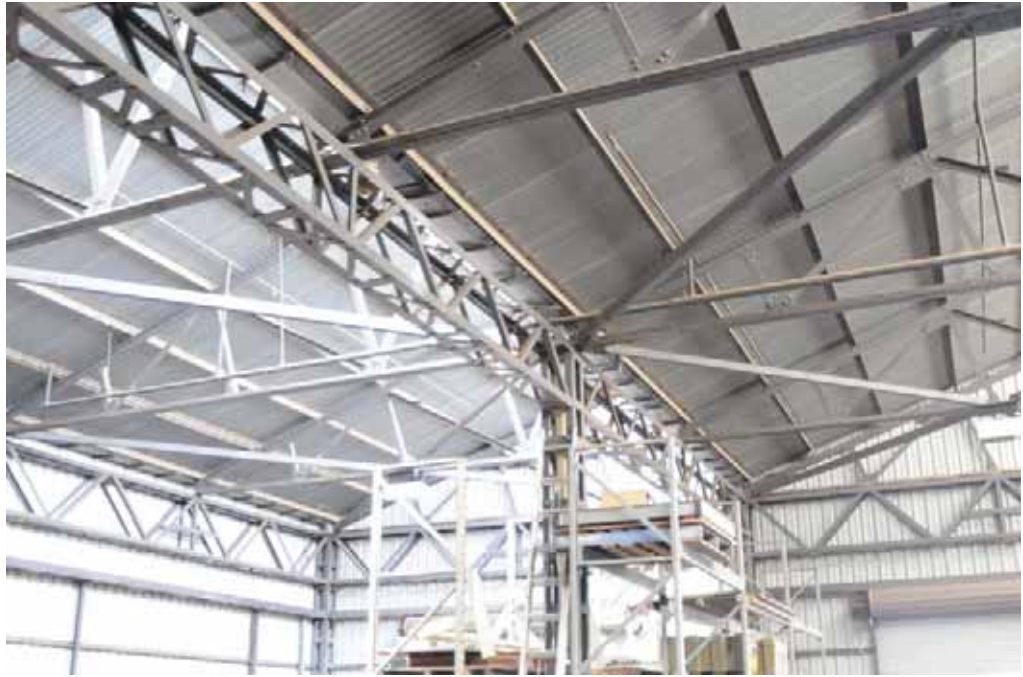
Figure 3.3 Interior steel frame detailing²⁶

Columns are set at 25' centres and made up from verticals of four 4" angles plated together with 4" flats. These support internal 2' x 1' boxed truss tie beams made up of four 4" angles joined by smaller raking angles vertically and corresponding flats top and bottom. Tie beams run into outer 3' x 1' beams that run around the building's perimeter and constructed in the same fashion. Triangular roof trusses at 12' 6" centres sit on top of tie beams. These are constructed from 4" angles laid back to back to form top and bottom chords. 4" angles are used to provide truss tension and compression members and attach to chords through flat plates sandwiched between top and bottom chord members. Lateral support to the building is provided by diagonally placed 4" angles running from roof truss bottom chord ends to the centre of adjacent truss in each bay and across the building.

Angle steel purlins originally supported “Large Corrugated ASB: Cement Roof” with a characteristic bull nosed detailing providing weathering and shade to the high level sawtooth roof windows. The original sawtooth roof windows were made up of four lapped panes vertically within 23 steel frames and with six equally positioned six pane hopper windows. Glazing was netting wired glass. These survive intact in the end bays of the building, otherwise they have been replaced with translucent corrugated plastic sheeting. The asbestos cement roofing has since been removed and replaced with corrugated metal.

Walls are supported on girts made up of 4” angles. Originally these supported Asbestos Cement sheeting in the upper half of the wall and vertically aligned corrugated galvanised iron in the lower half. This detail remains on the other example of this building type at the former Gona Barracks. These original materials have since been replaced with a vertical ribbed metal section. Original externally mounted sliding doors to each bay on the north and south elevations of the building have been replaced with roller doors.

The integrity of the structural steel frame of C48 is high, however the integrity of its original cladding detailing is low. The building appears to have been regularly maintained.
