## Remediation of the former fire training ground

## RAAF Base Richmond: timeline of remediation activity

# PFAS INVESTIGATION AND MANAGEMENT PROGRAM

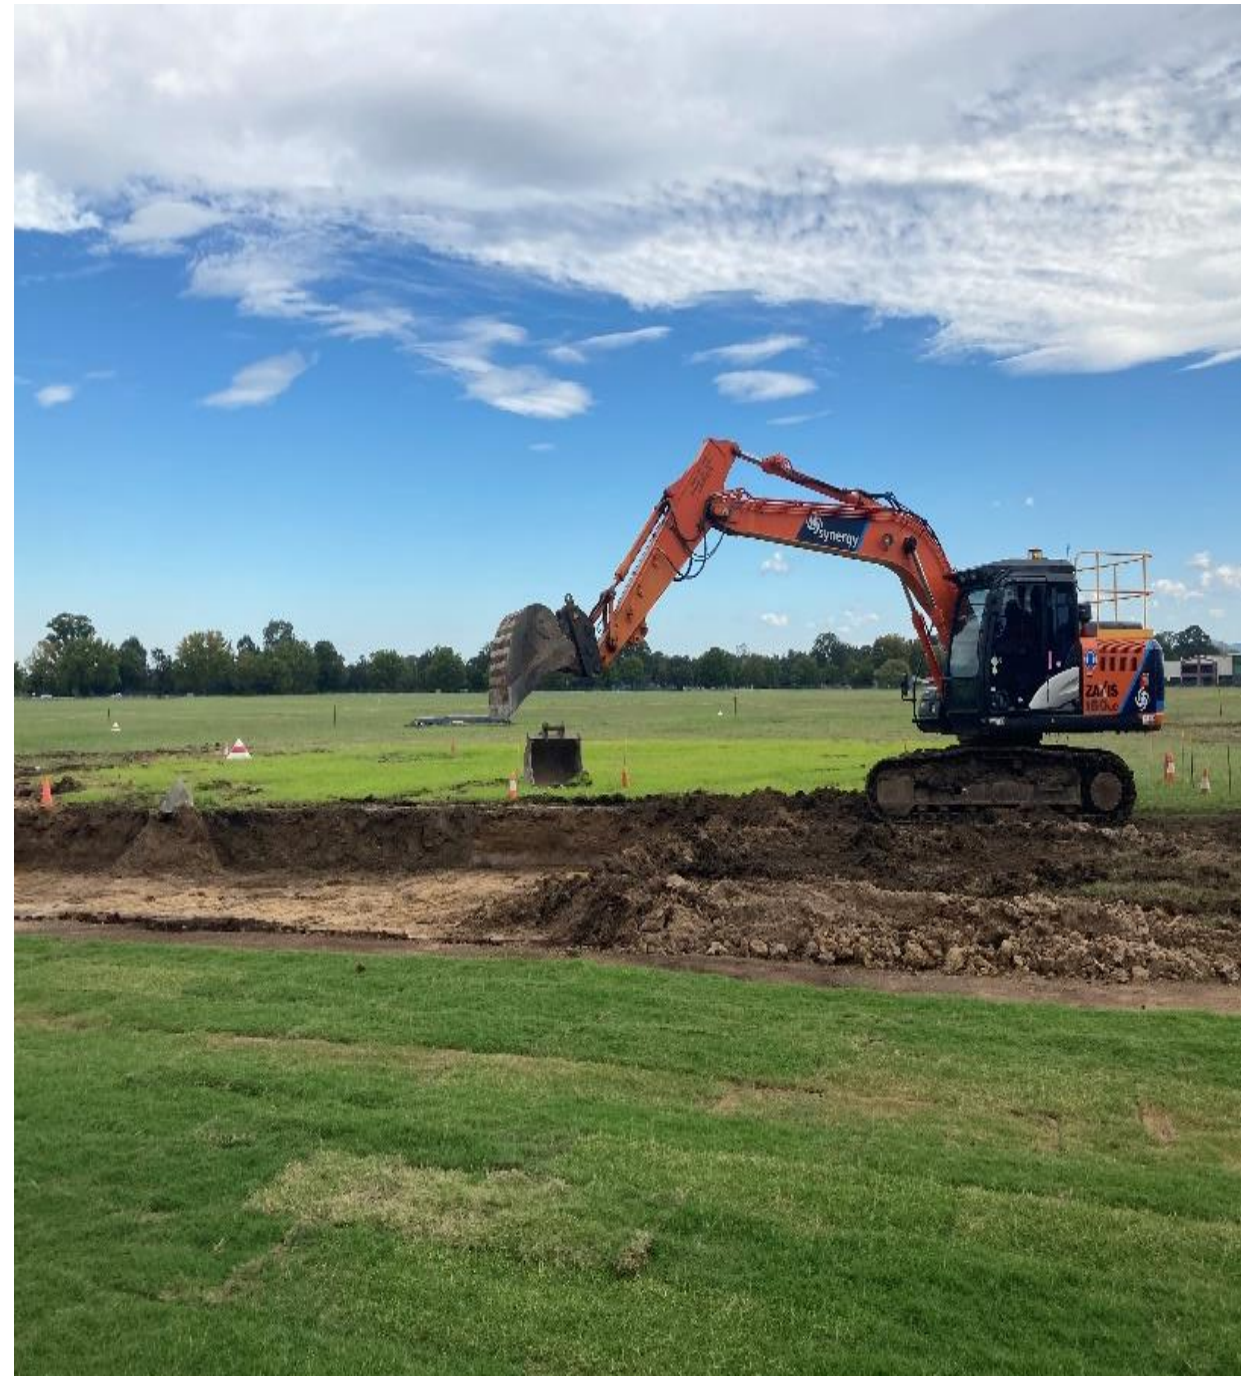
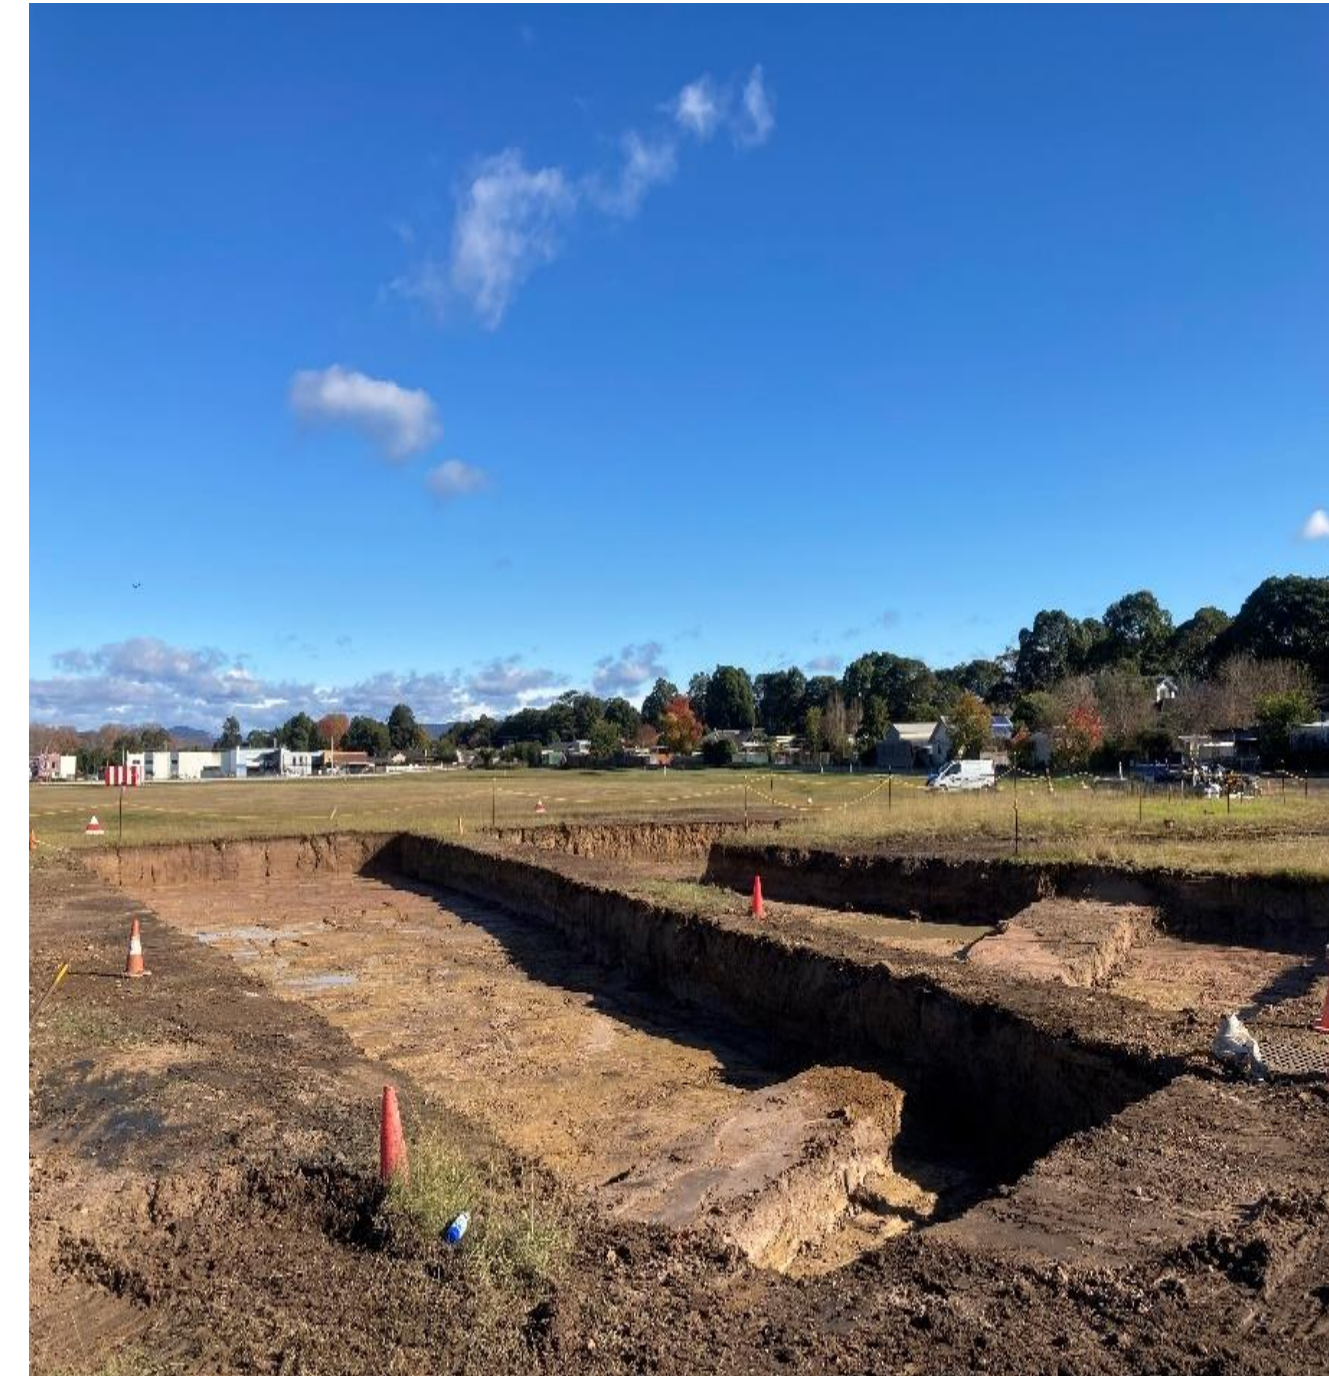
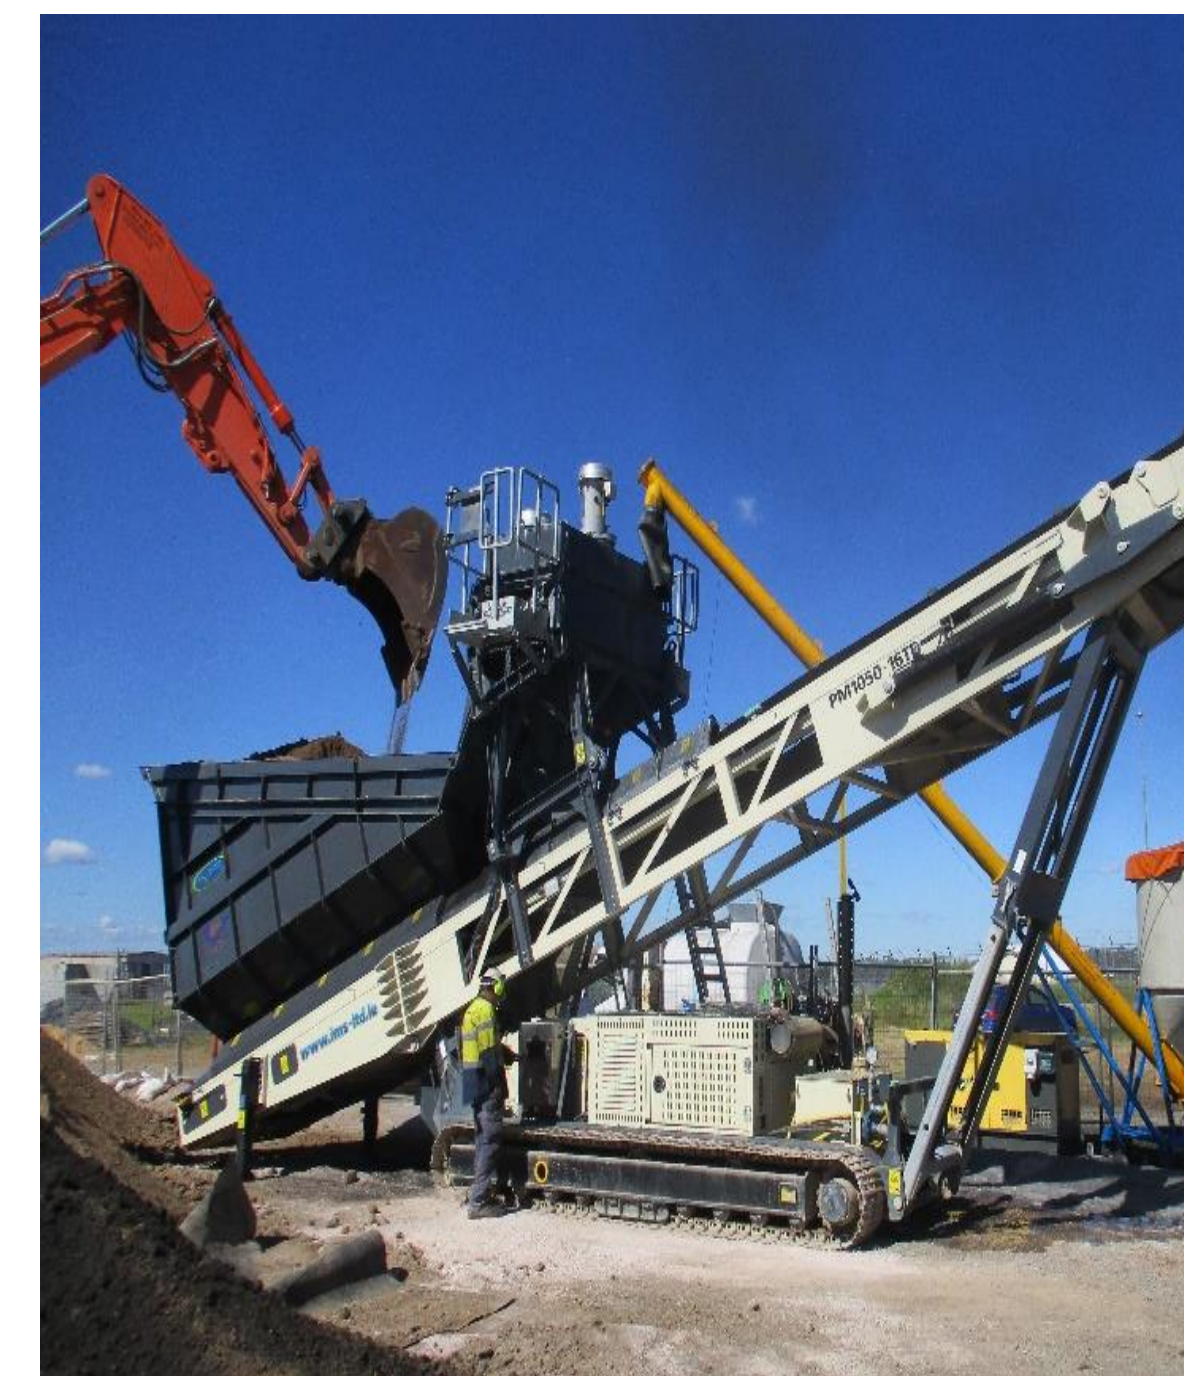
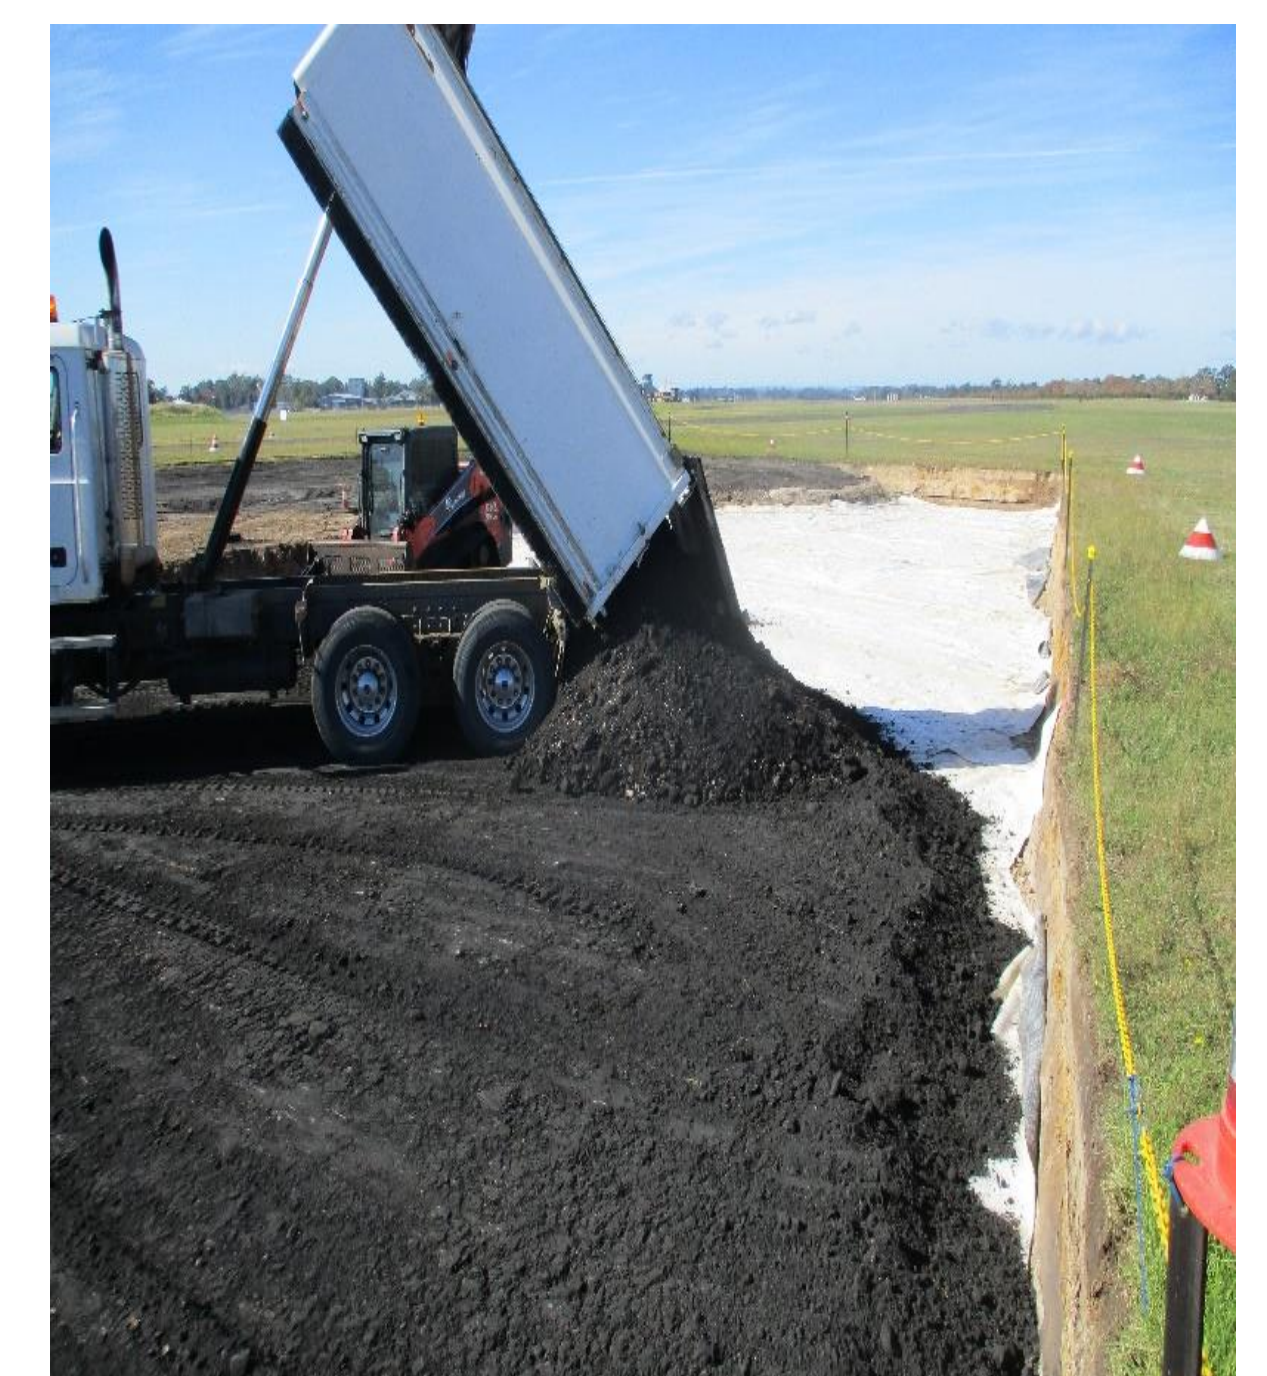
3,900 m<sup>3</sup> of soil excavated for treatment destruction off base.

**Action**

Clay liner placed in excavation pits above remaining PFAS contaminated soils

**Outcome**

PFAS migration from this source area reduced by almost 99%.

Soil stabilisation prevents PFAS from moving, and is:

- ✓ a suitable treatment for moderate to low level PFAS contaminated soil
- ✓ a more sustainable option.

Contaminated soils with very high concentrations of PFAS were:

- ✓ removed from the base
- ✓ destroyed at a licensed facility in Victoria by a high temperature treatment process.

Clay liners:

- ✓ prevents rainwater removing remaining PFAS from the contaminated soil at depth.

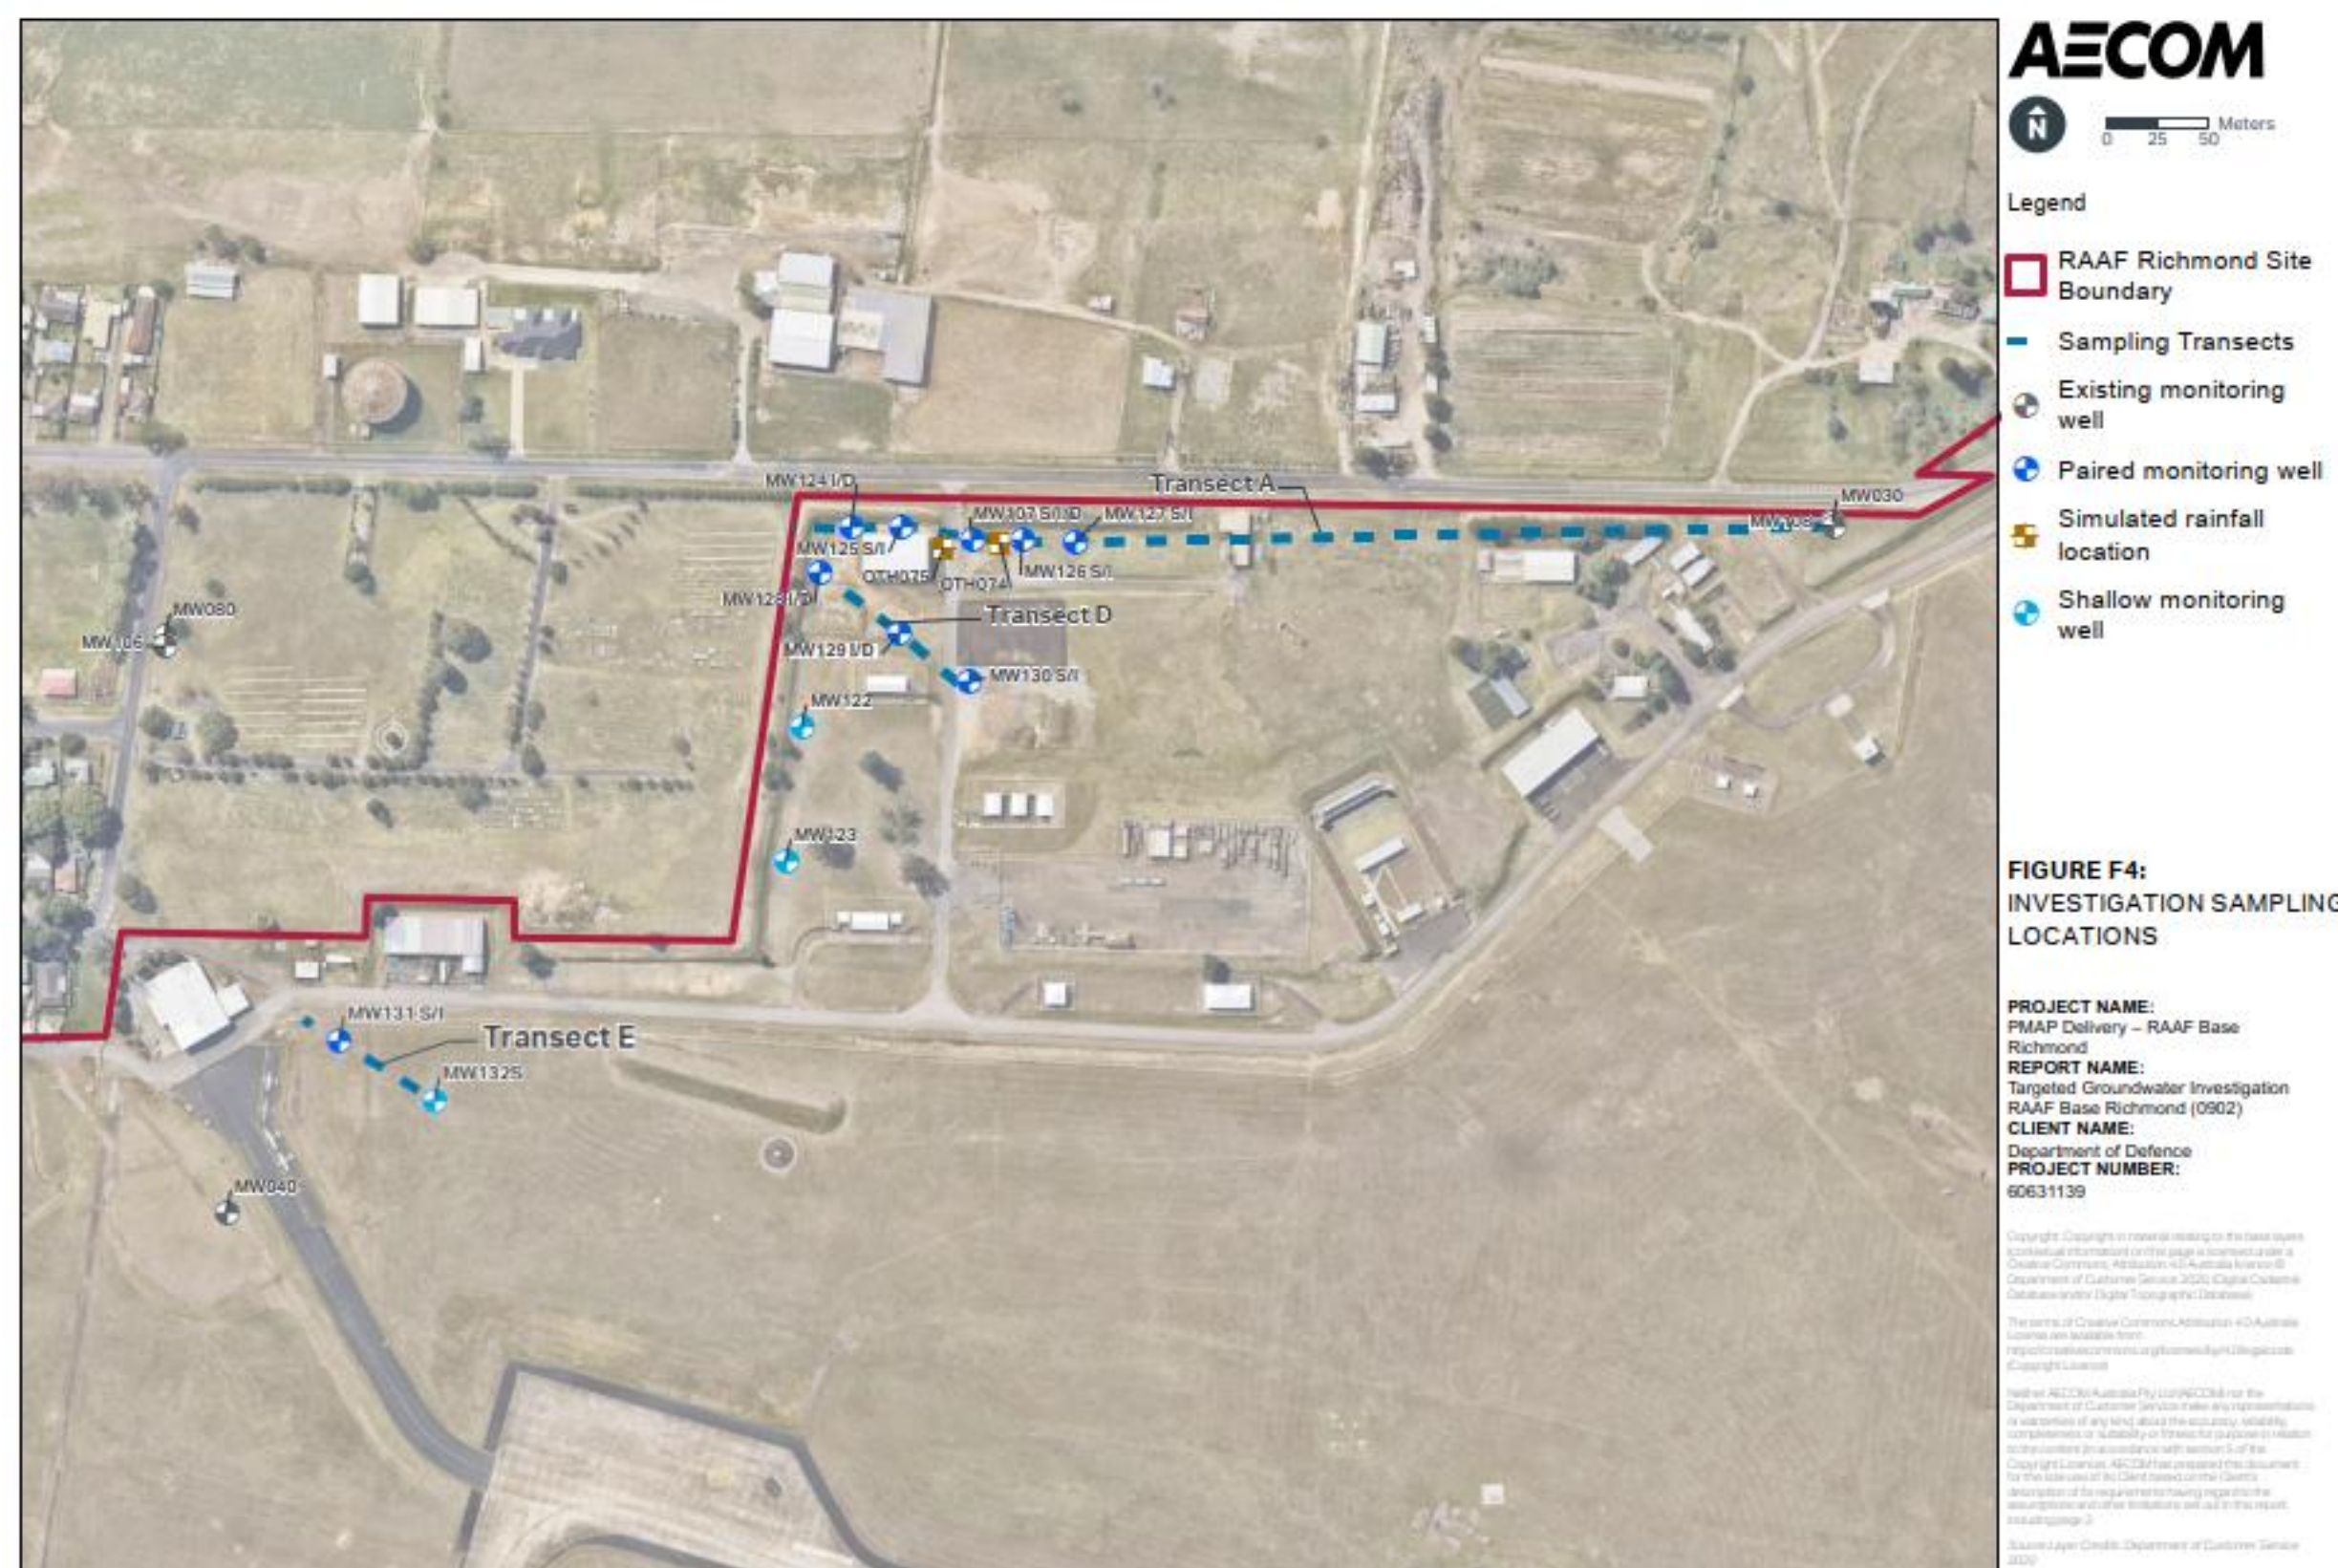
Investigation sampling locations

- A further 20 groundwater wells were installed, two simulated rainfall tests were undertaken and soil samples were collected in the area to locate a possible source of the PFAS.

- Elevated PFAS concentrations were localised in shallow groundwater near the base boundary and not associated with a broader PFAS plume.
- Increases may have been the result of heavy and prolonged rainfall moving PFAS from a nearby source area into shallow groundwater.
- The movement of PFAS from the base is mostly from surface water
- Further monitoring of groundwater wells on the northern boundary will be undertaken to detect changes in PFAS concentrations and movement over the northern boundary, especially in response to rainfall.
- While the overall amount of PFAS leaving the Base is low, Defence will conduct ongoing groundwater remedial works in this area.
- The remediation works may include a passive absorptive barrier or pump and treat.
- These works are expected to commence in early to mid 2024.
