PFAS Investigation and Management Program

RAAF Base Richmond
PFAS Investigation and Management Program update
Tuesday 22 August 2023

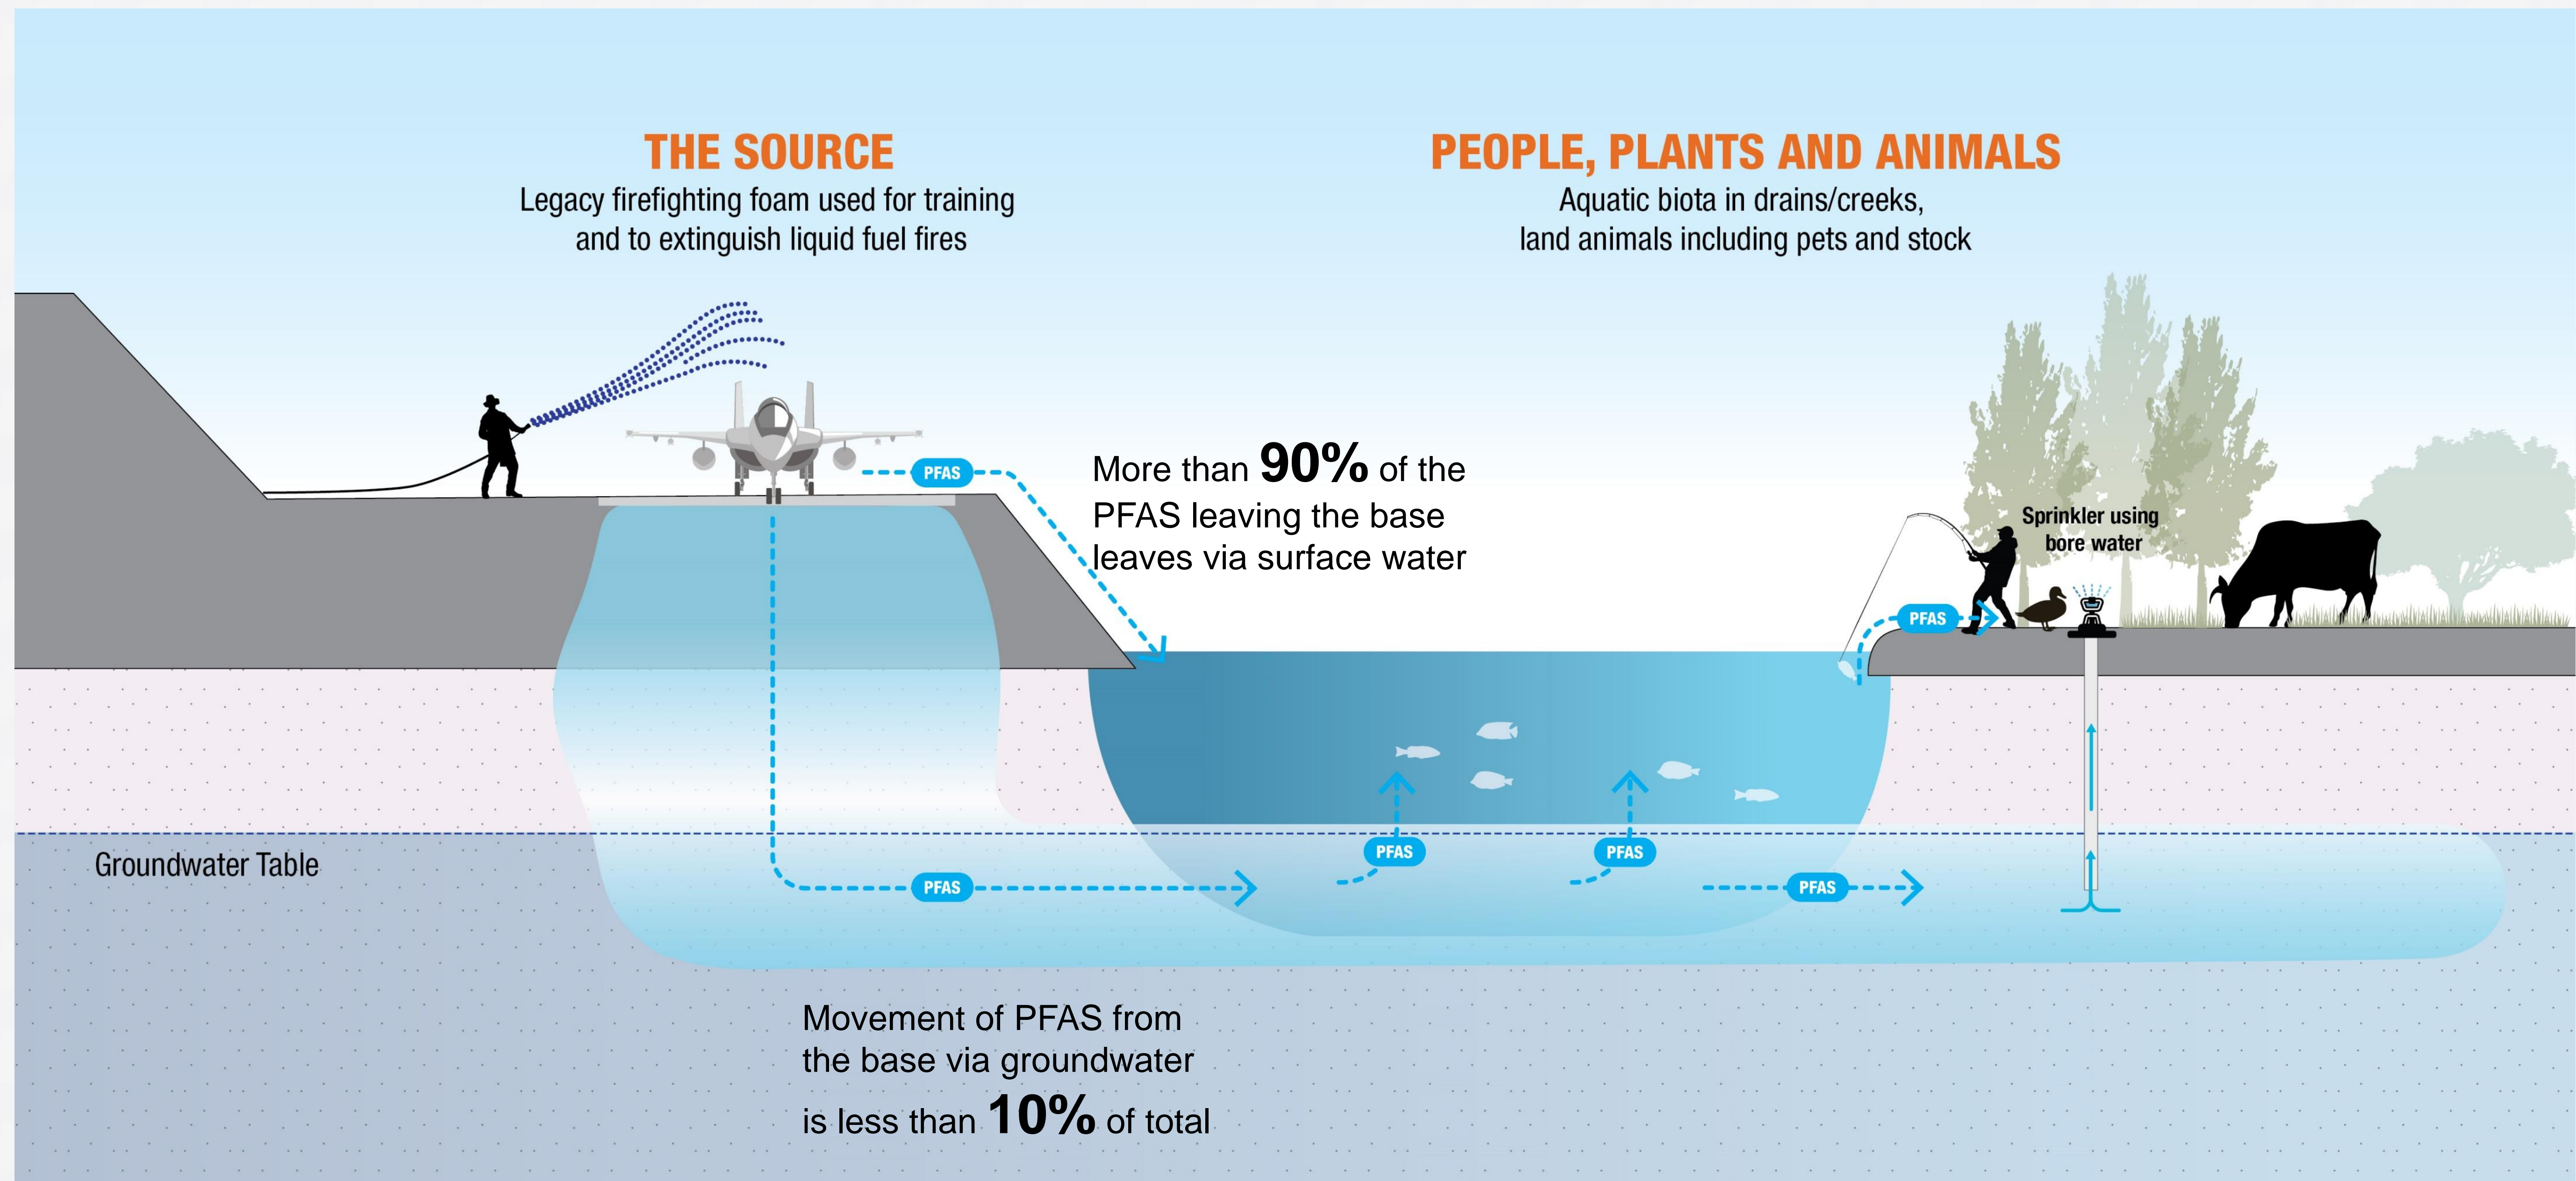
PFAS movement through the environment

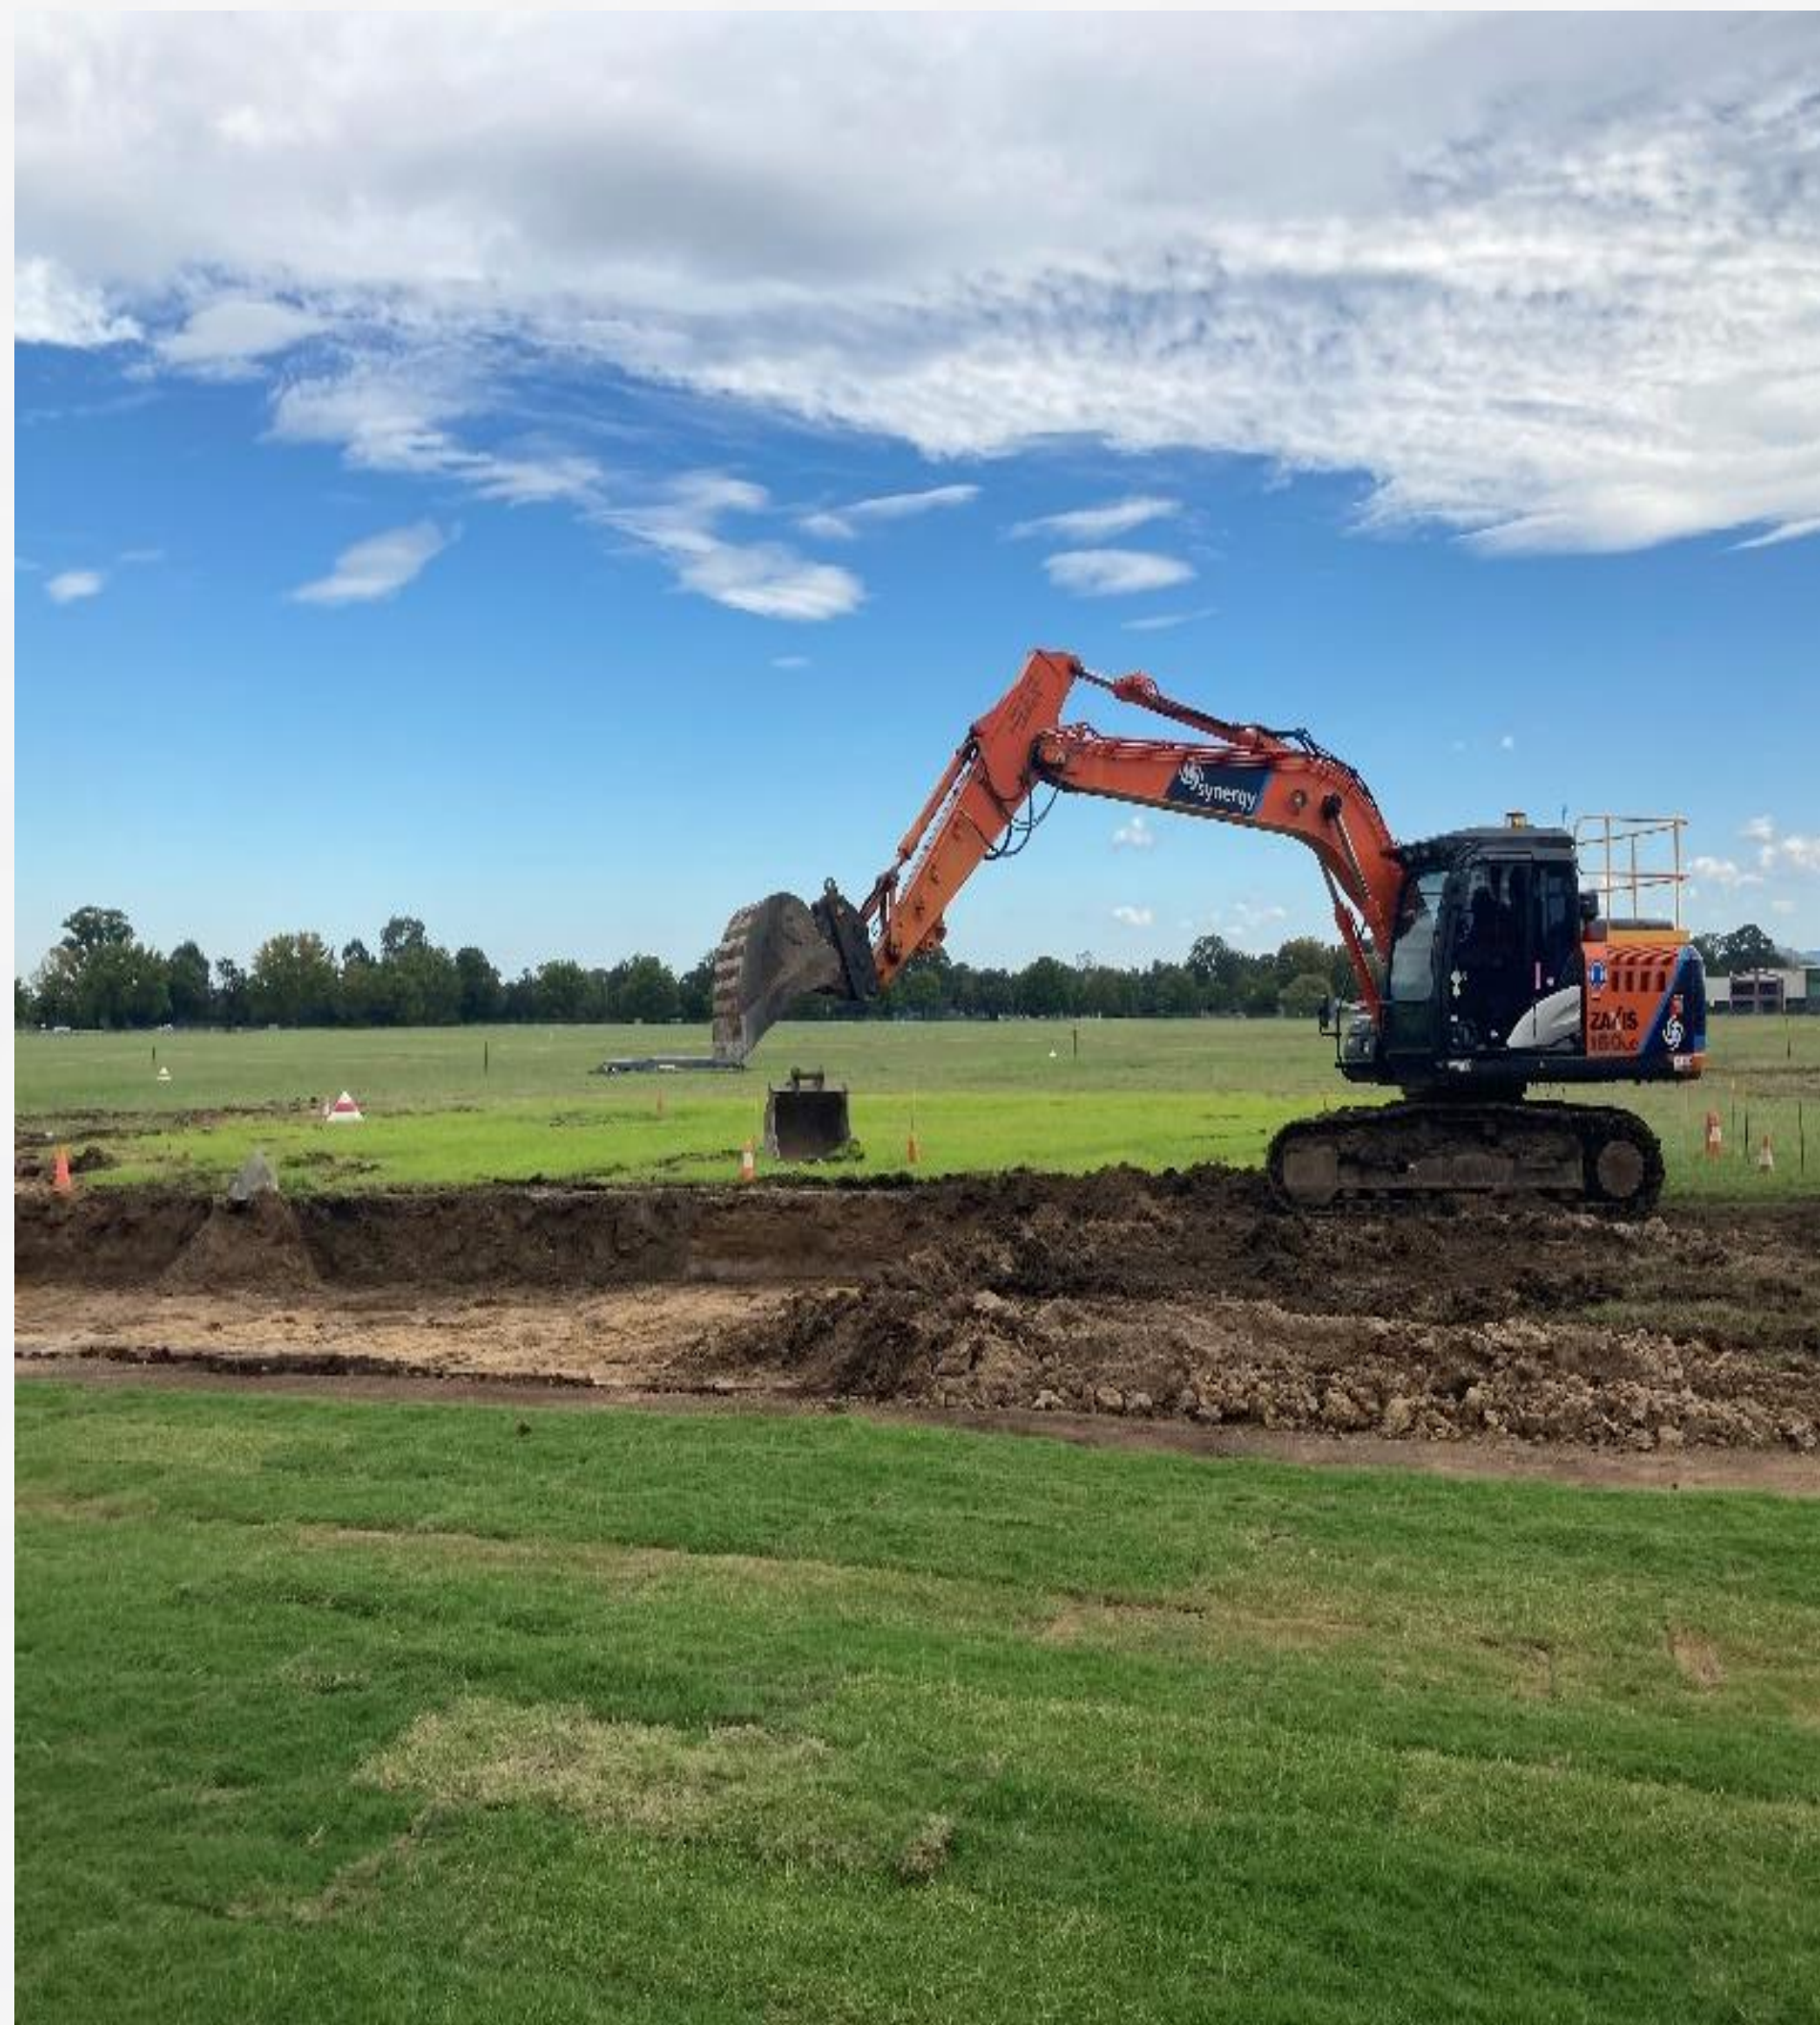
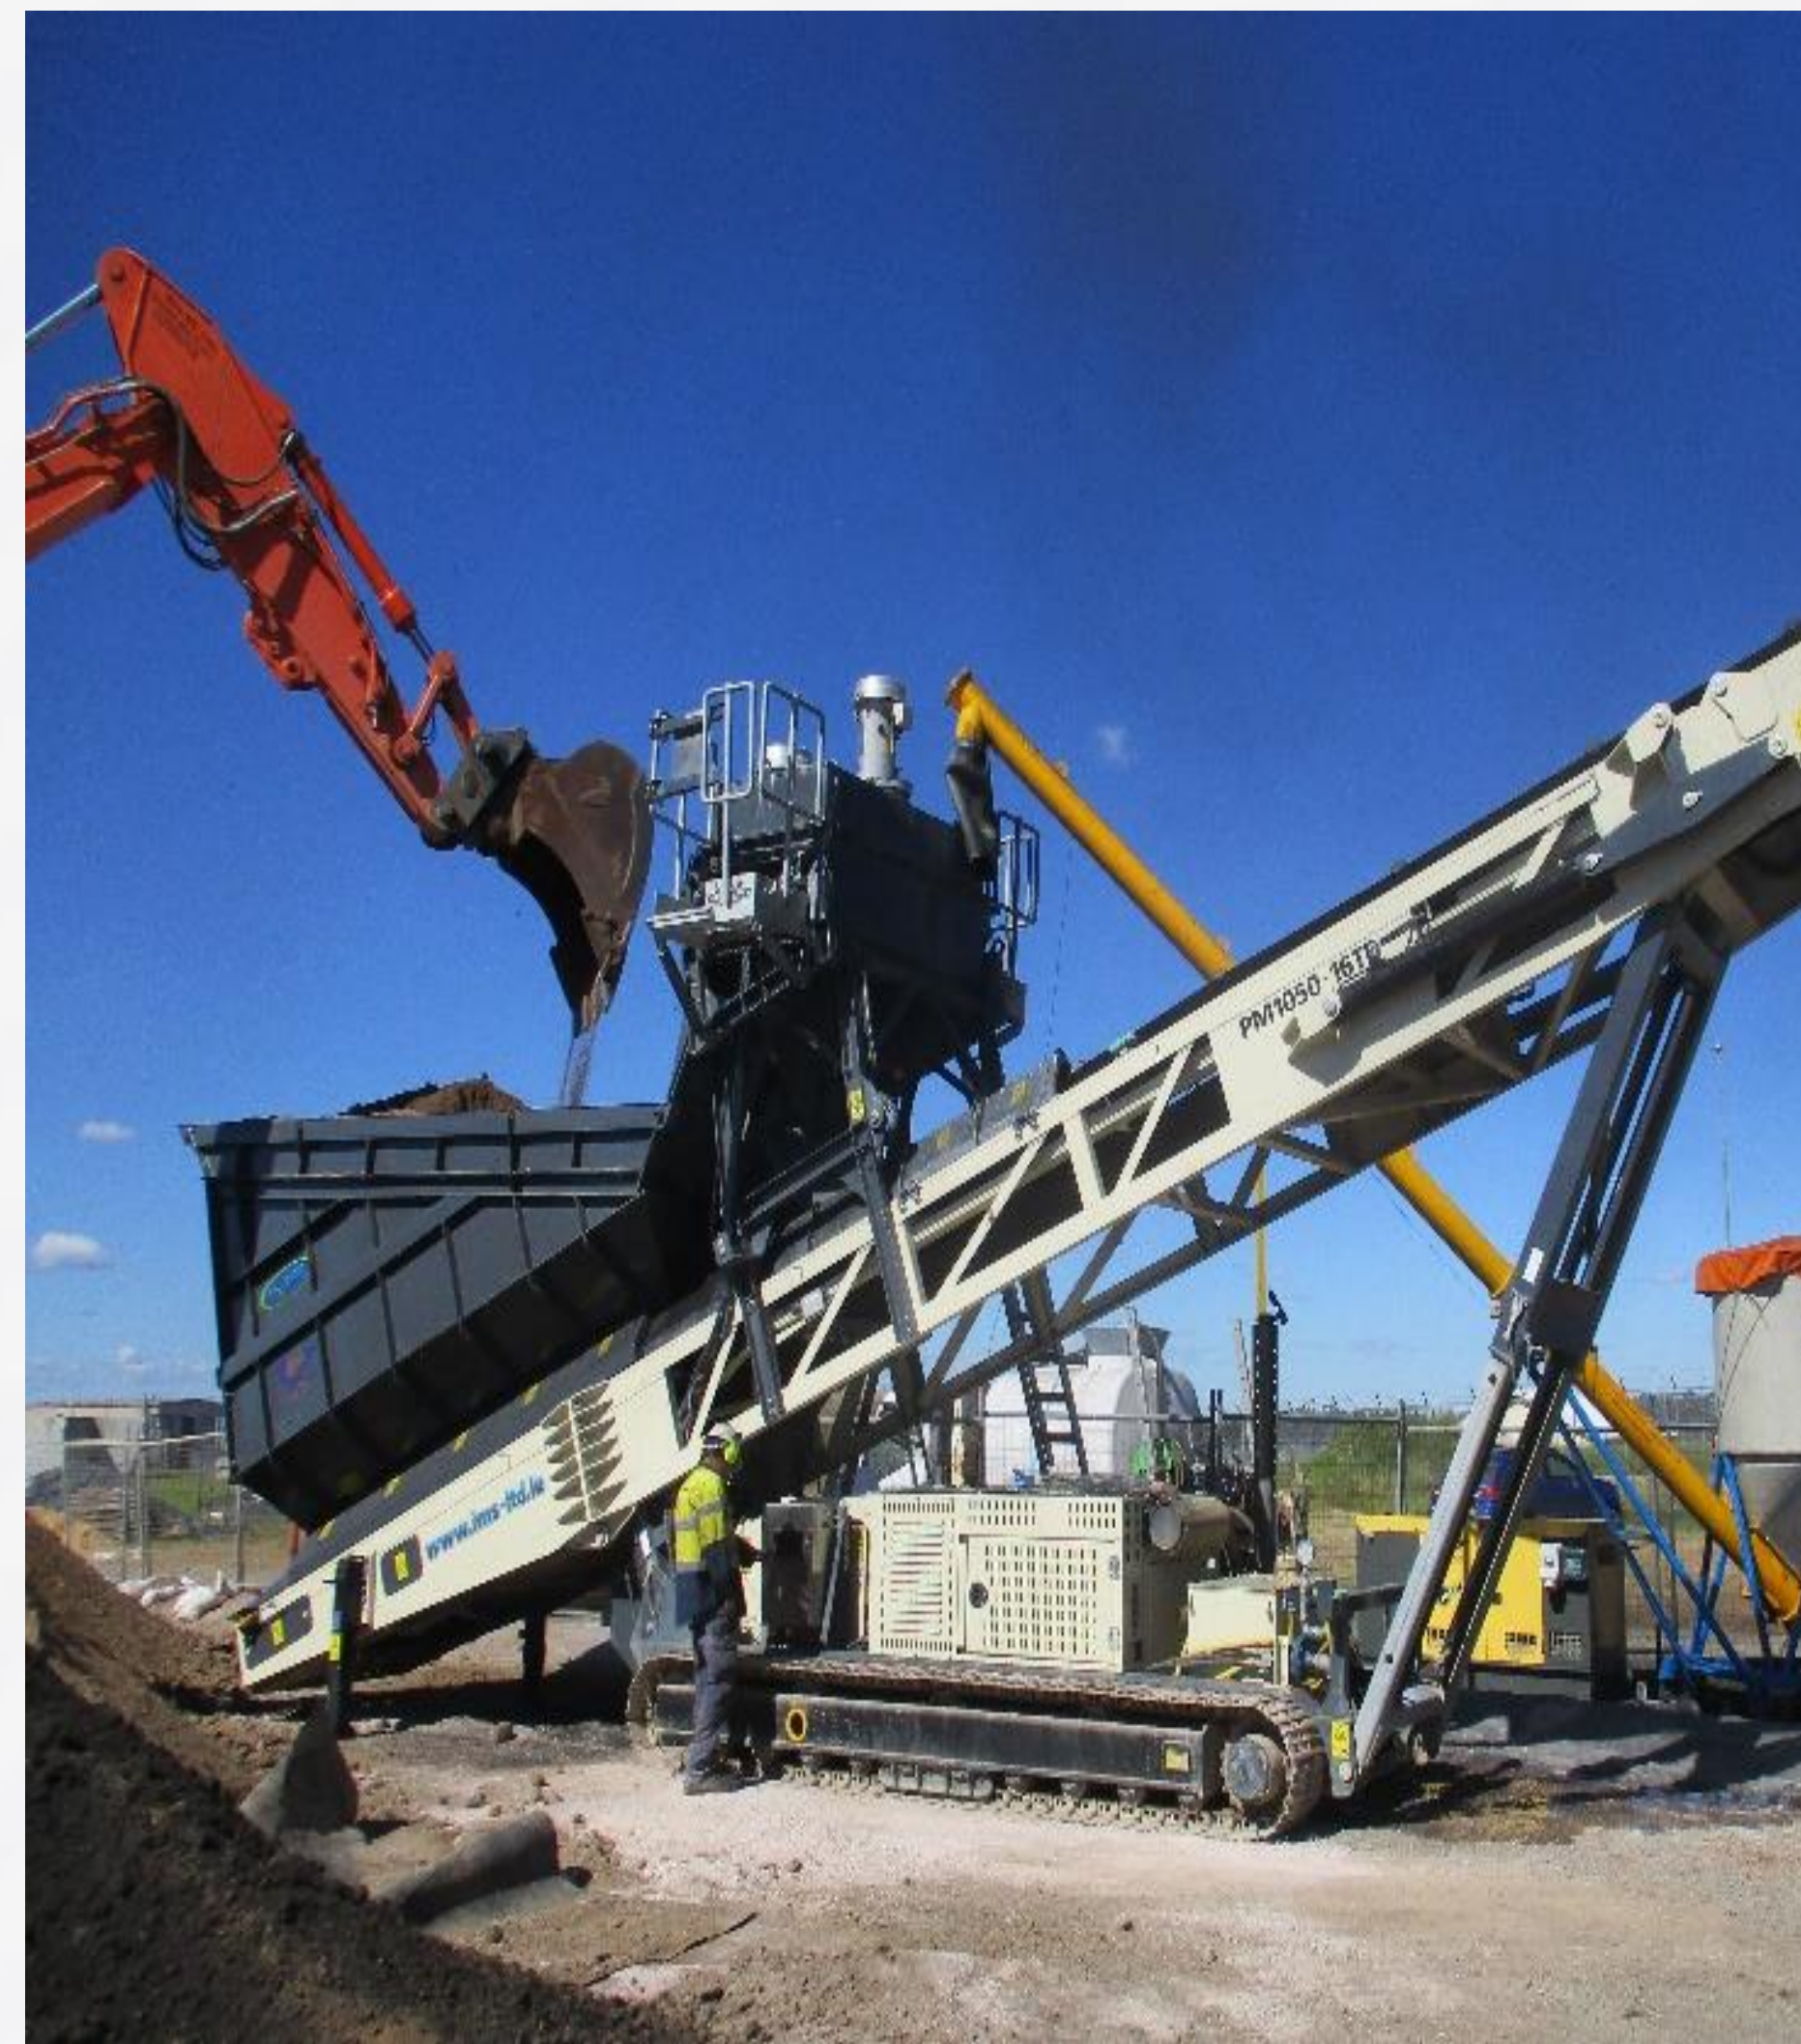
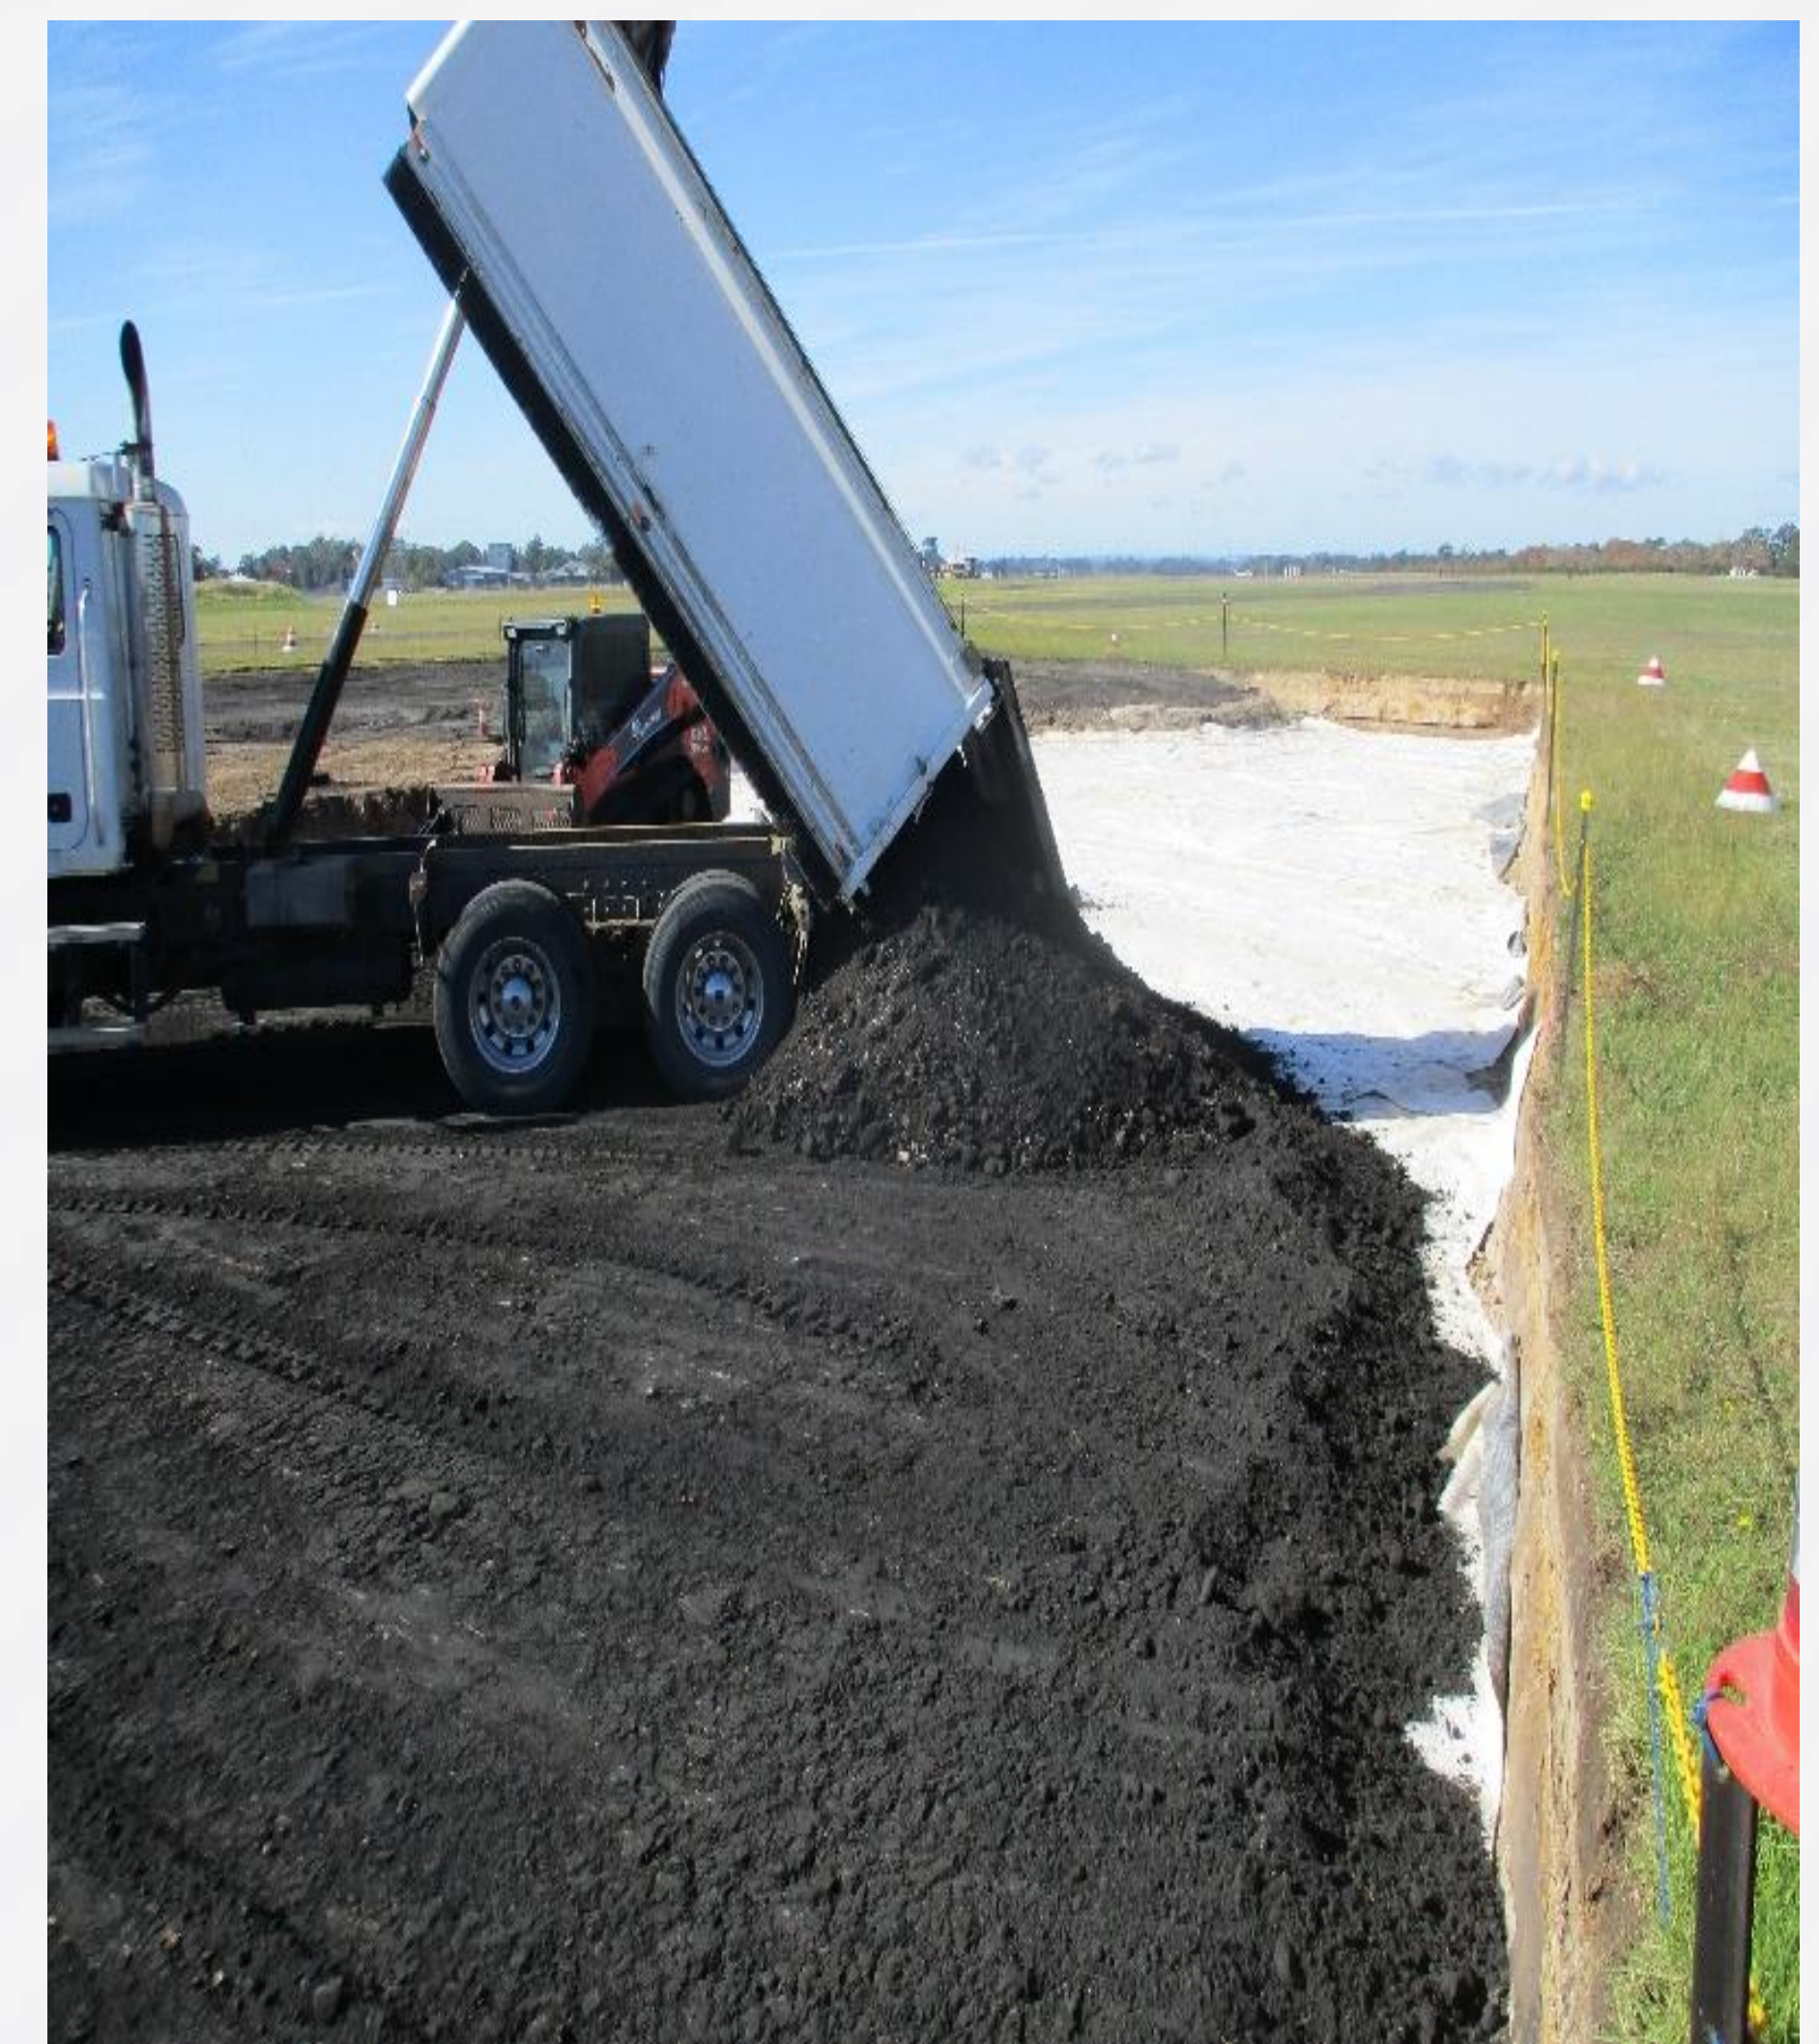
Completed remediation - former fire training ground

3,900 m³ of soil excavated for treatment off base.

Clay liner placed in excavation pits above remaining PFAS contaminated soils.

PFAS migration off site from this source area reduced by almost 99%.

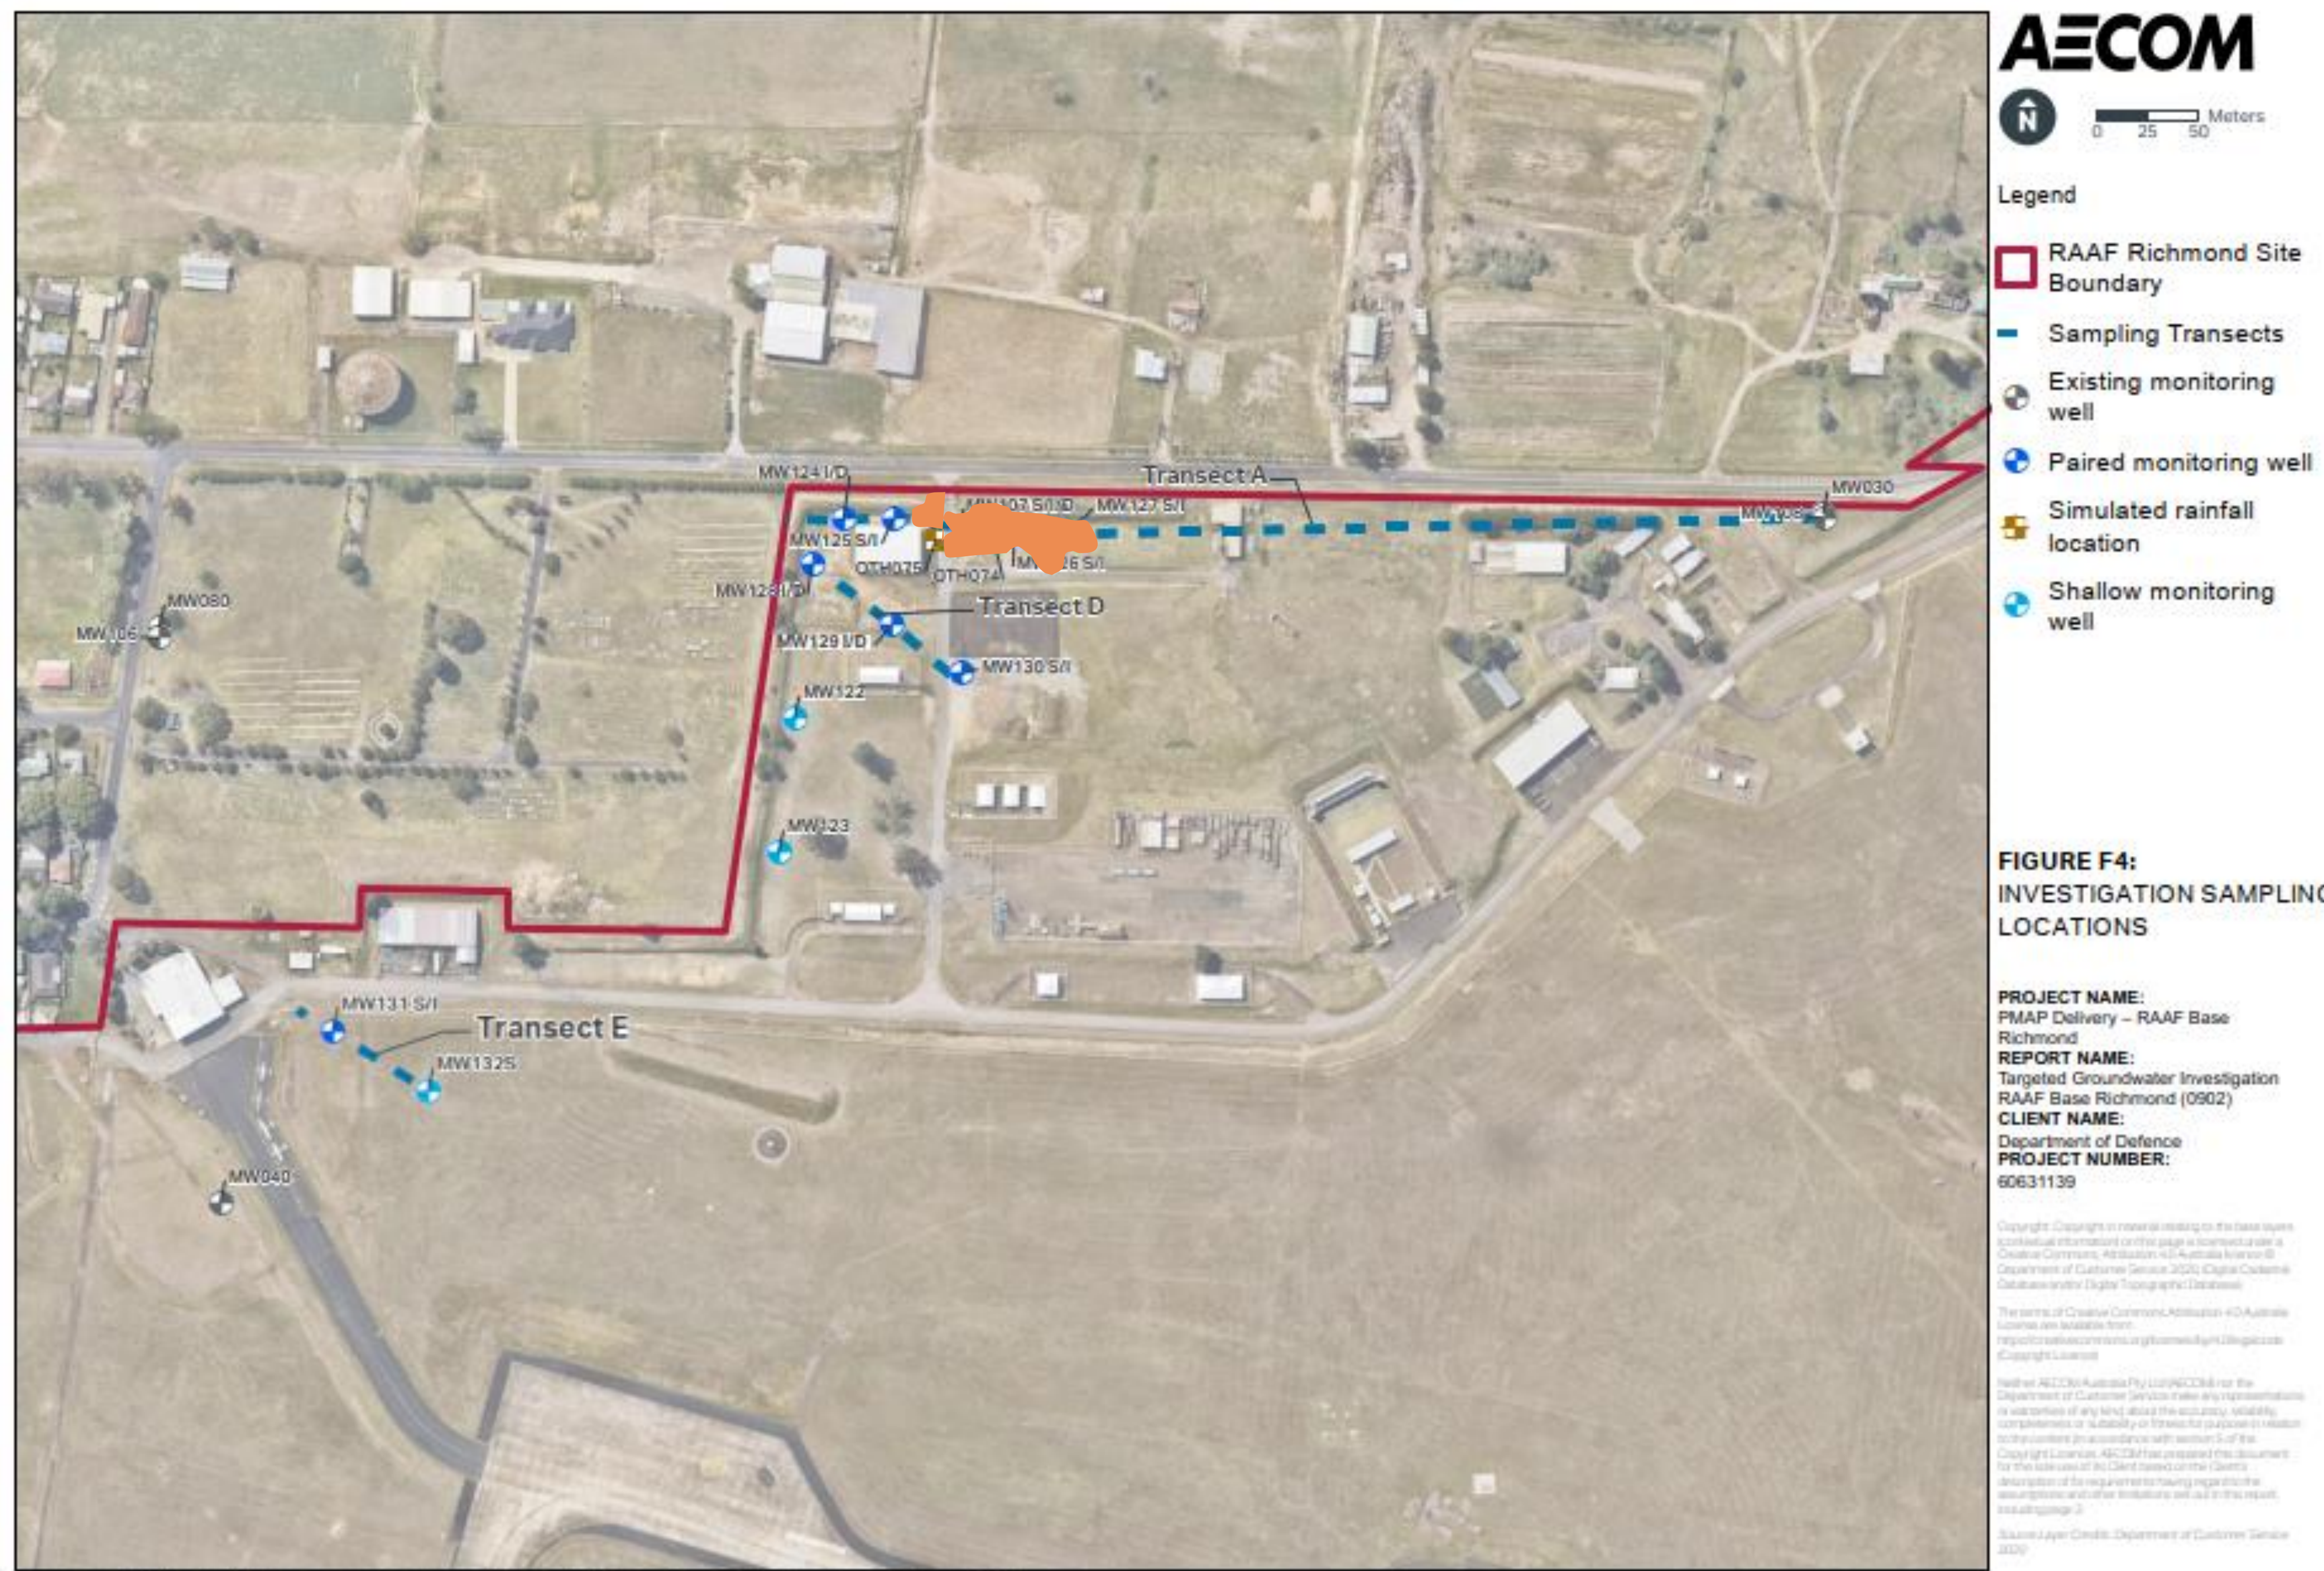
Proposed groundwater remediation map

Testing of groundwater at the northern boundary reported a sudden increase in PFAS concentrations.

A further 20 groundwater wells were installed and soil samples were collected in the area to locate a possible source of the PFAS.

Heightened PFAS levels were found in shallow groundwater near the base boundary. This may have been the result from heavy and prolonged rainfall.

While the overall amount of PFAS moving through groundwater at the northern boundary is low, Defence will conduct some targeted groundwater remedial works in this area.
