RAAF Base Townsville timeline of program

RAAF Base Townsville Management Area and source areas

RAAF Base Townsville - Soil remediation at the Former Fire Training Ground

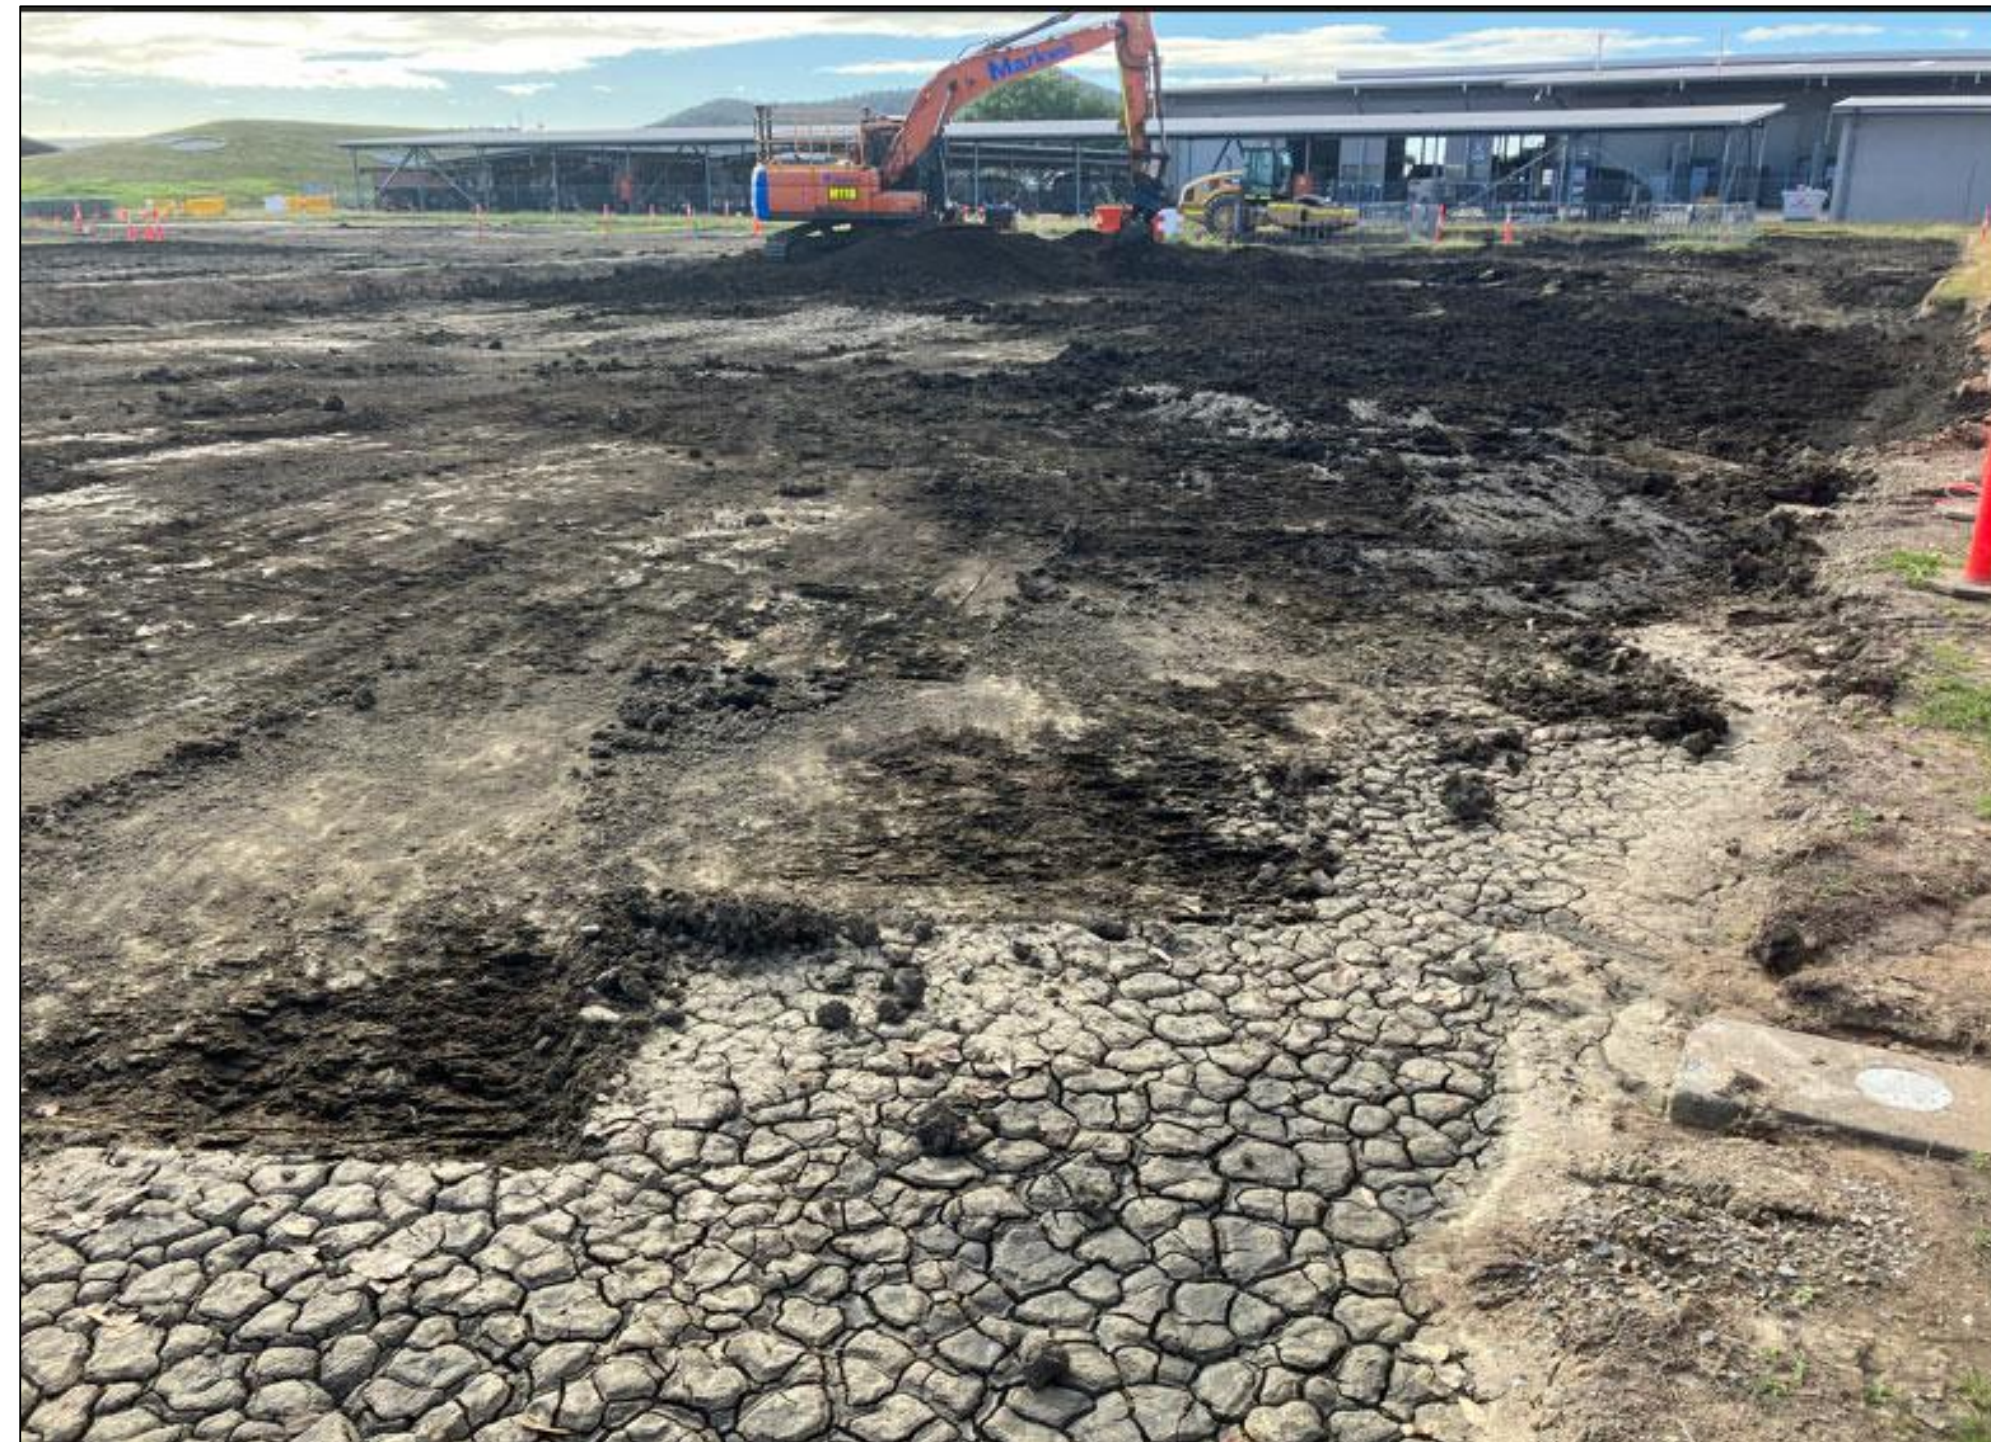
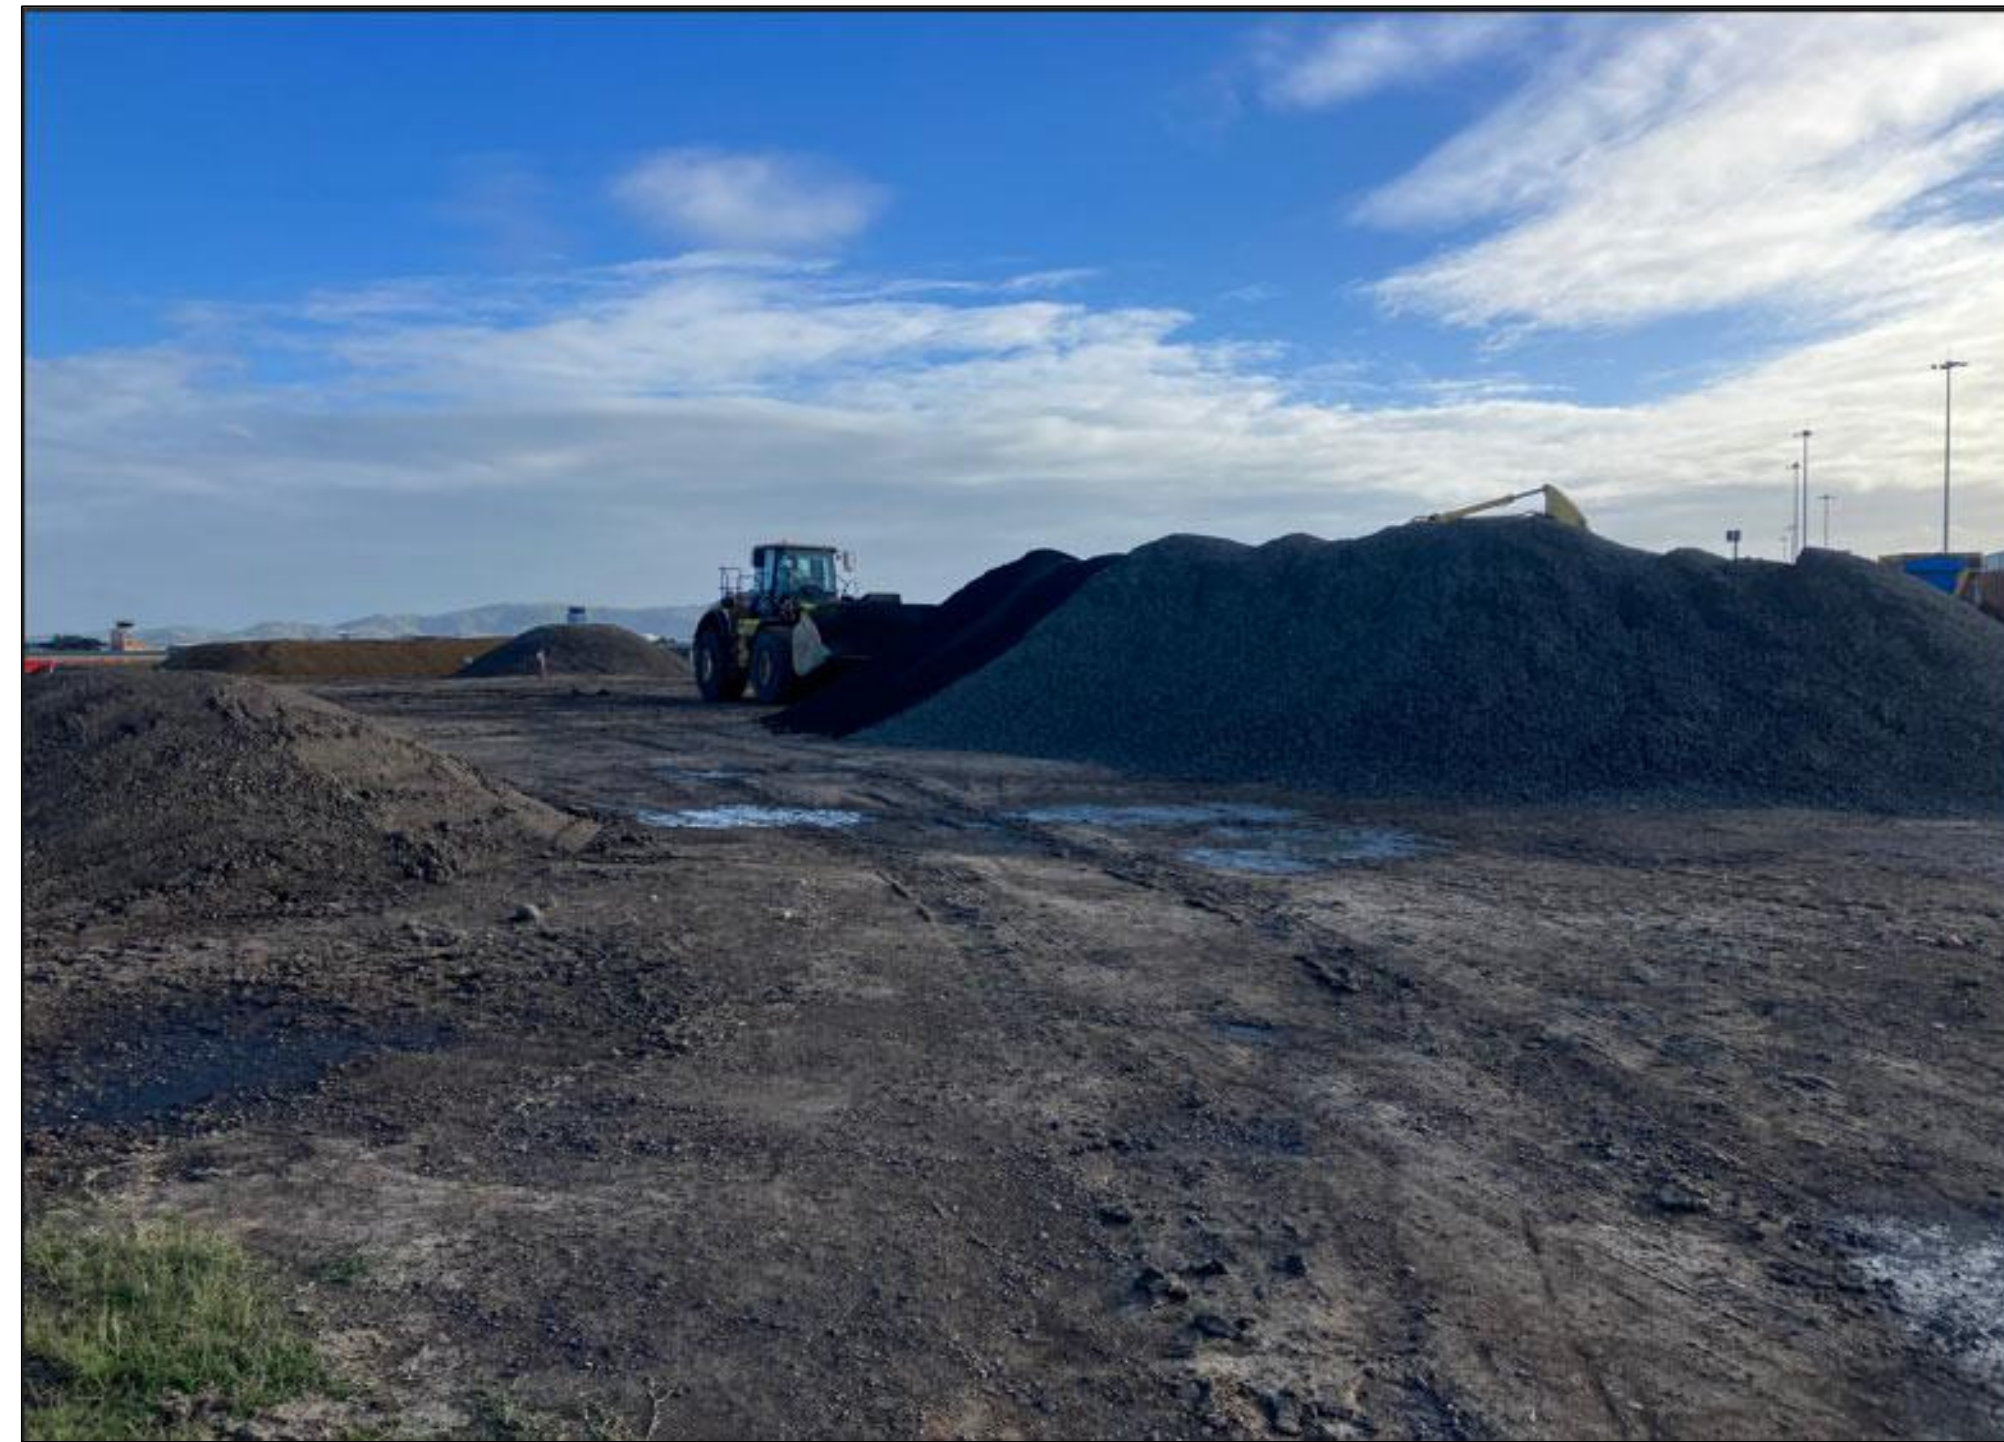
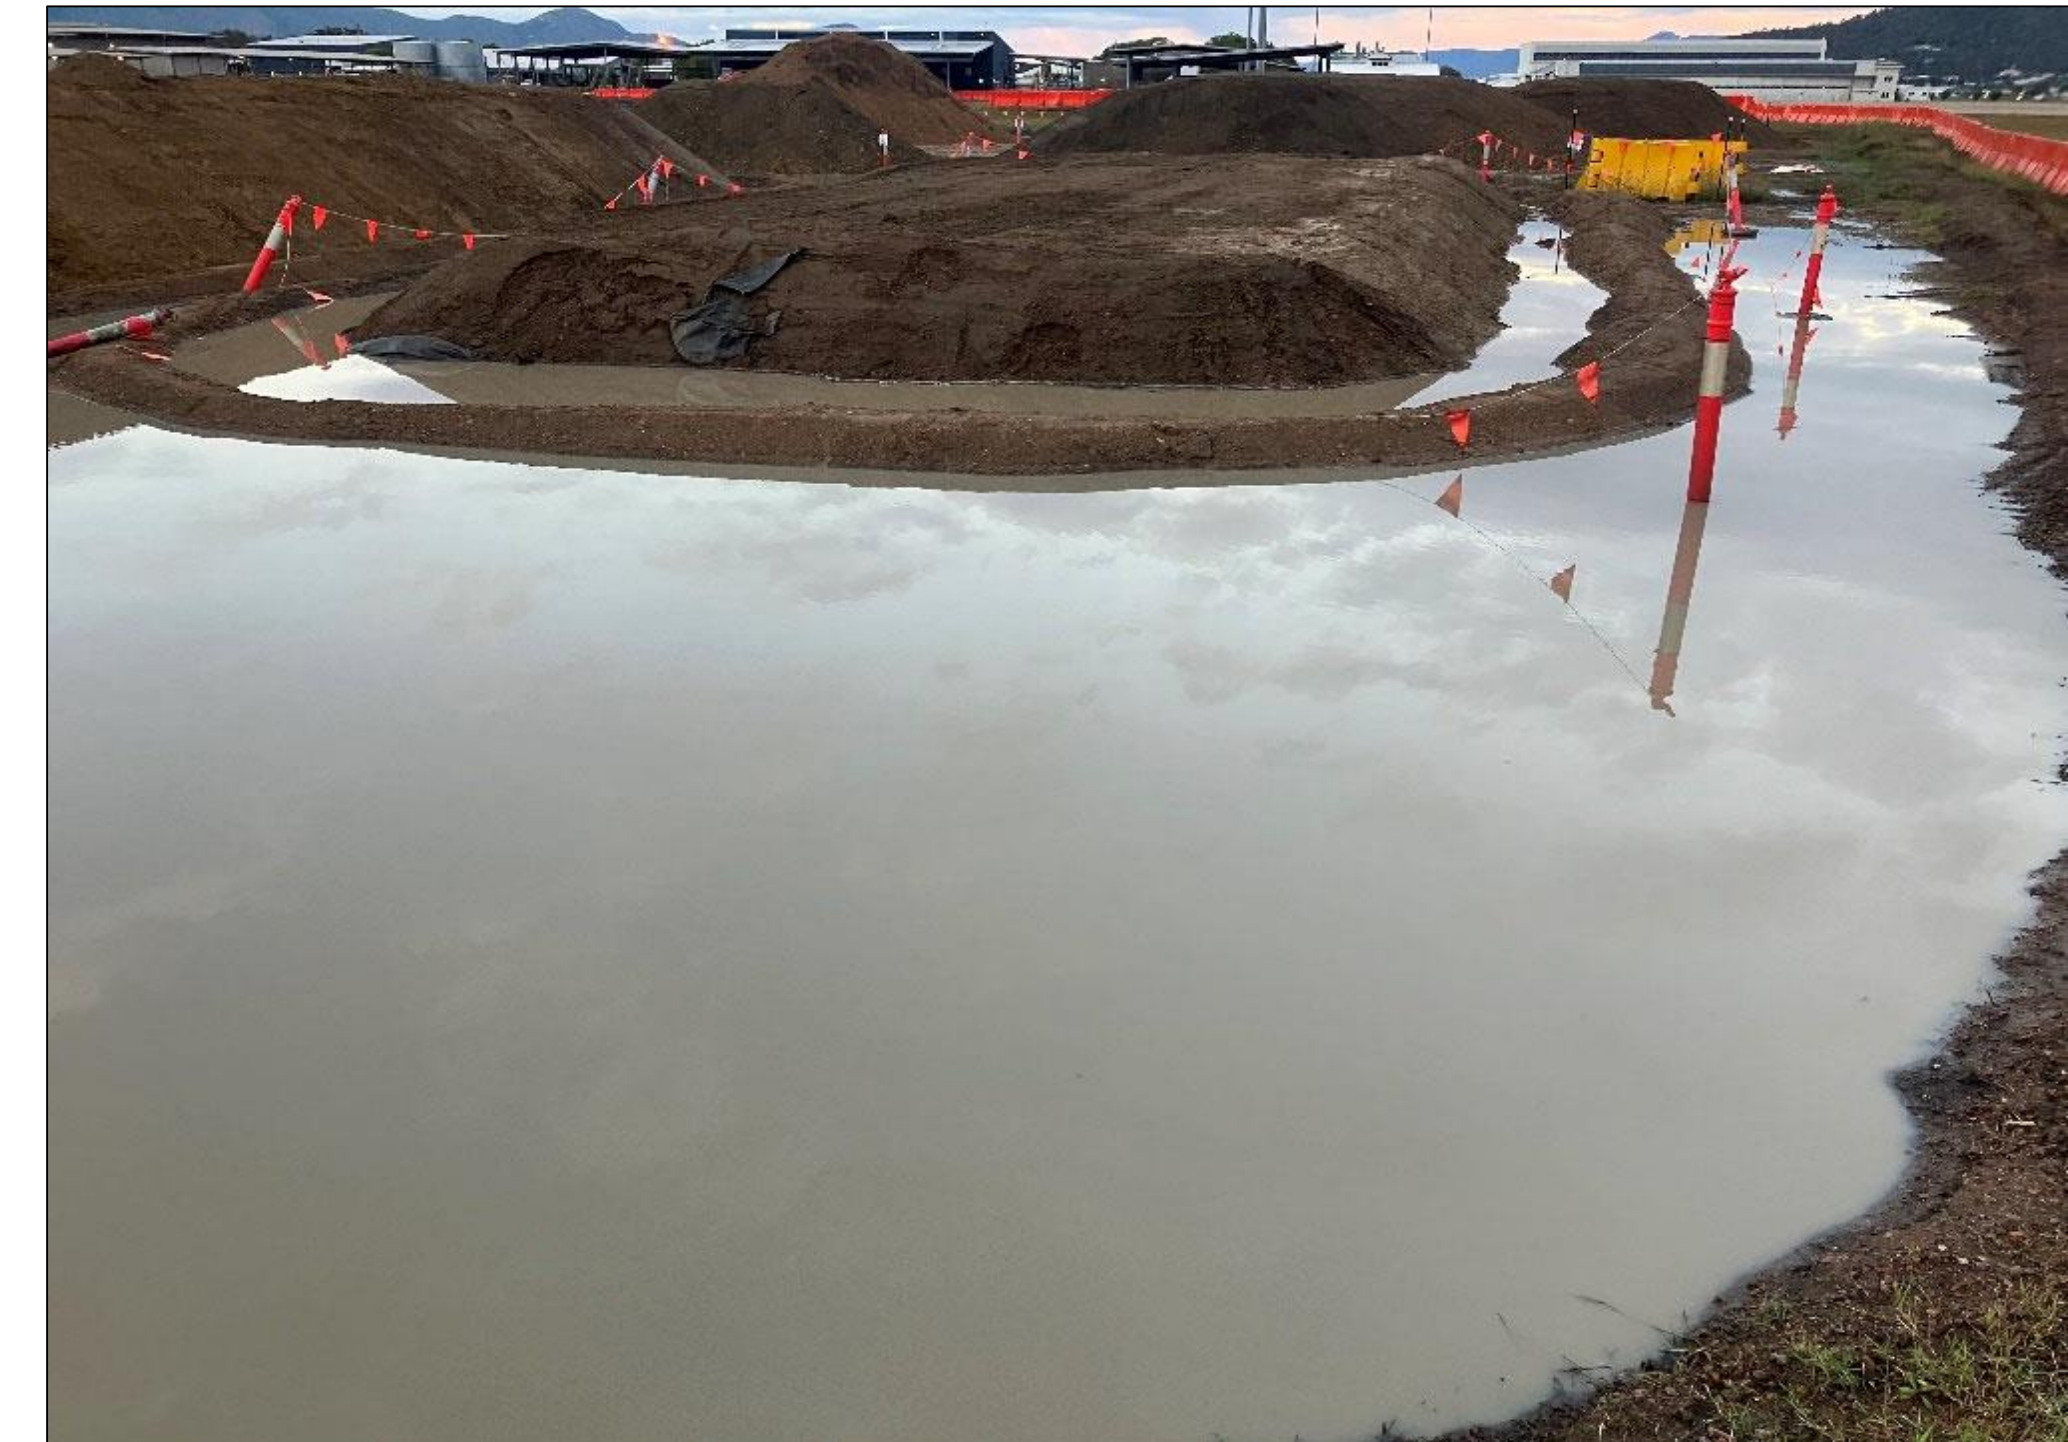
7500 m³ of soil excavated for treatment, or destruction off base.

Drainage remediation, soil compaction and 'guard trenches' reducing PFAS migration

Soil stabilisation prevents PFAS from moving, and is:

- ✓ a suitable treatment for moderate to low level PFAS contaminated soil
- ✓ a more sustainable option.

Contaminated soils with very high concentrations of PFAS were:

- ✓ removed from the base
- ✓ destroyed at a licensed facility in Victoria by a high temperature treatment process.

Drainage remediation, soil compaction and guard trenches:

- ✓ reduce rain water infiltration and PFAS migration from the soil into the drainage system and surrounding environment.
