Community Consultative Session

PFAS Investigation and Management Program

RAAF Base Townsville and Lavarack Barracks
PFAS investigations, remediation and monitoring update
Tuesday 31 October 2023

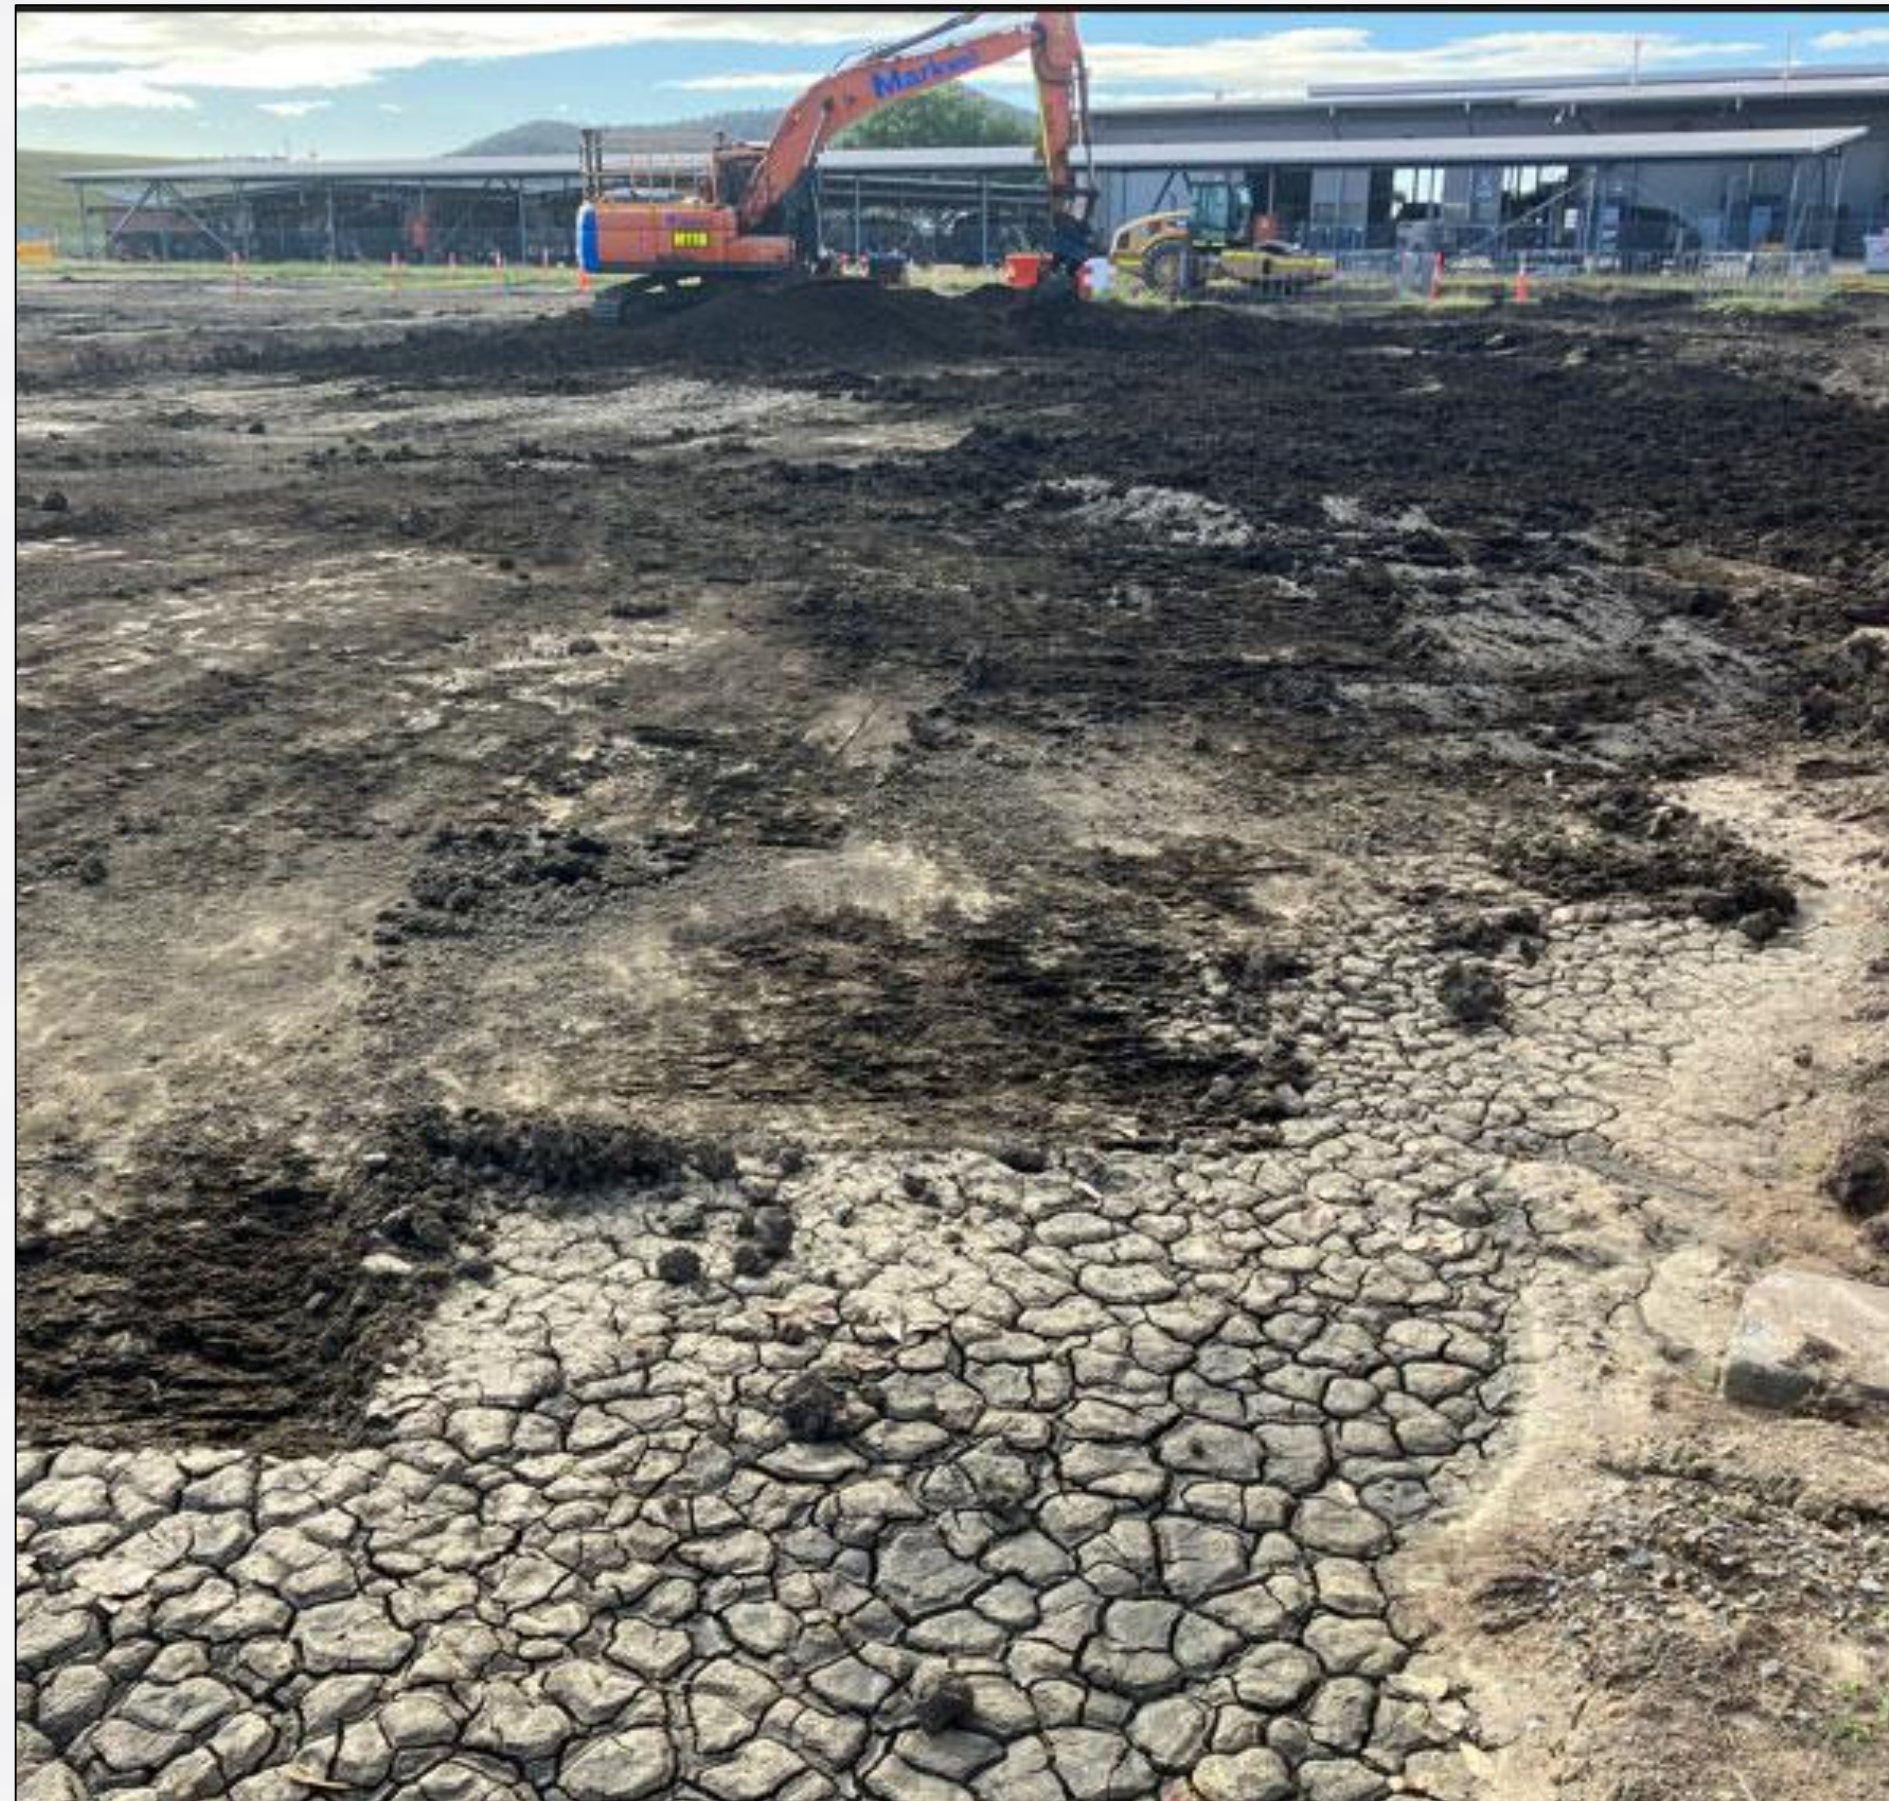
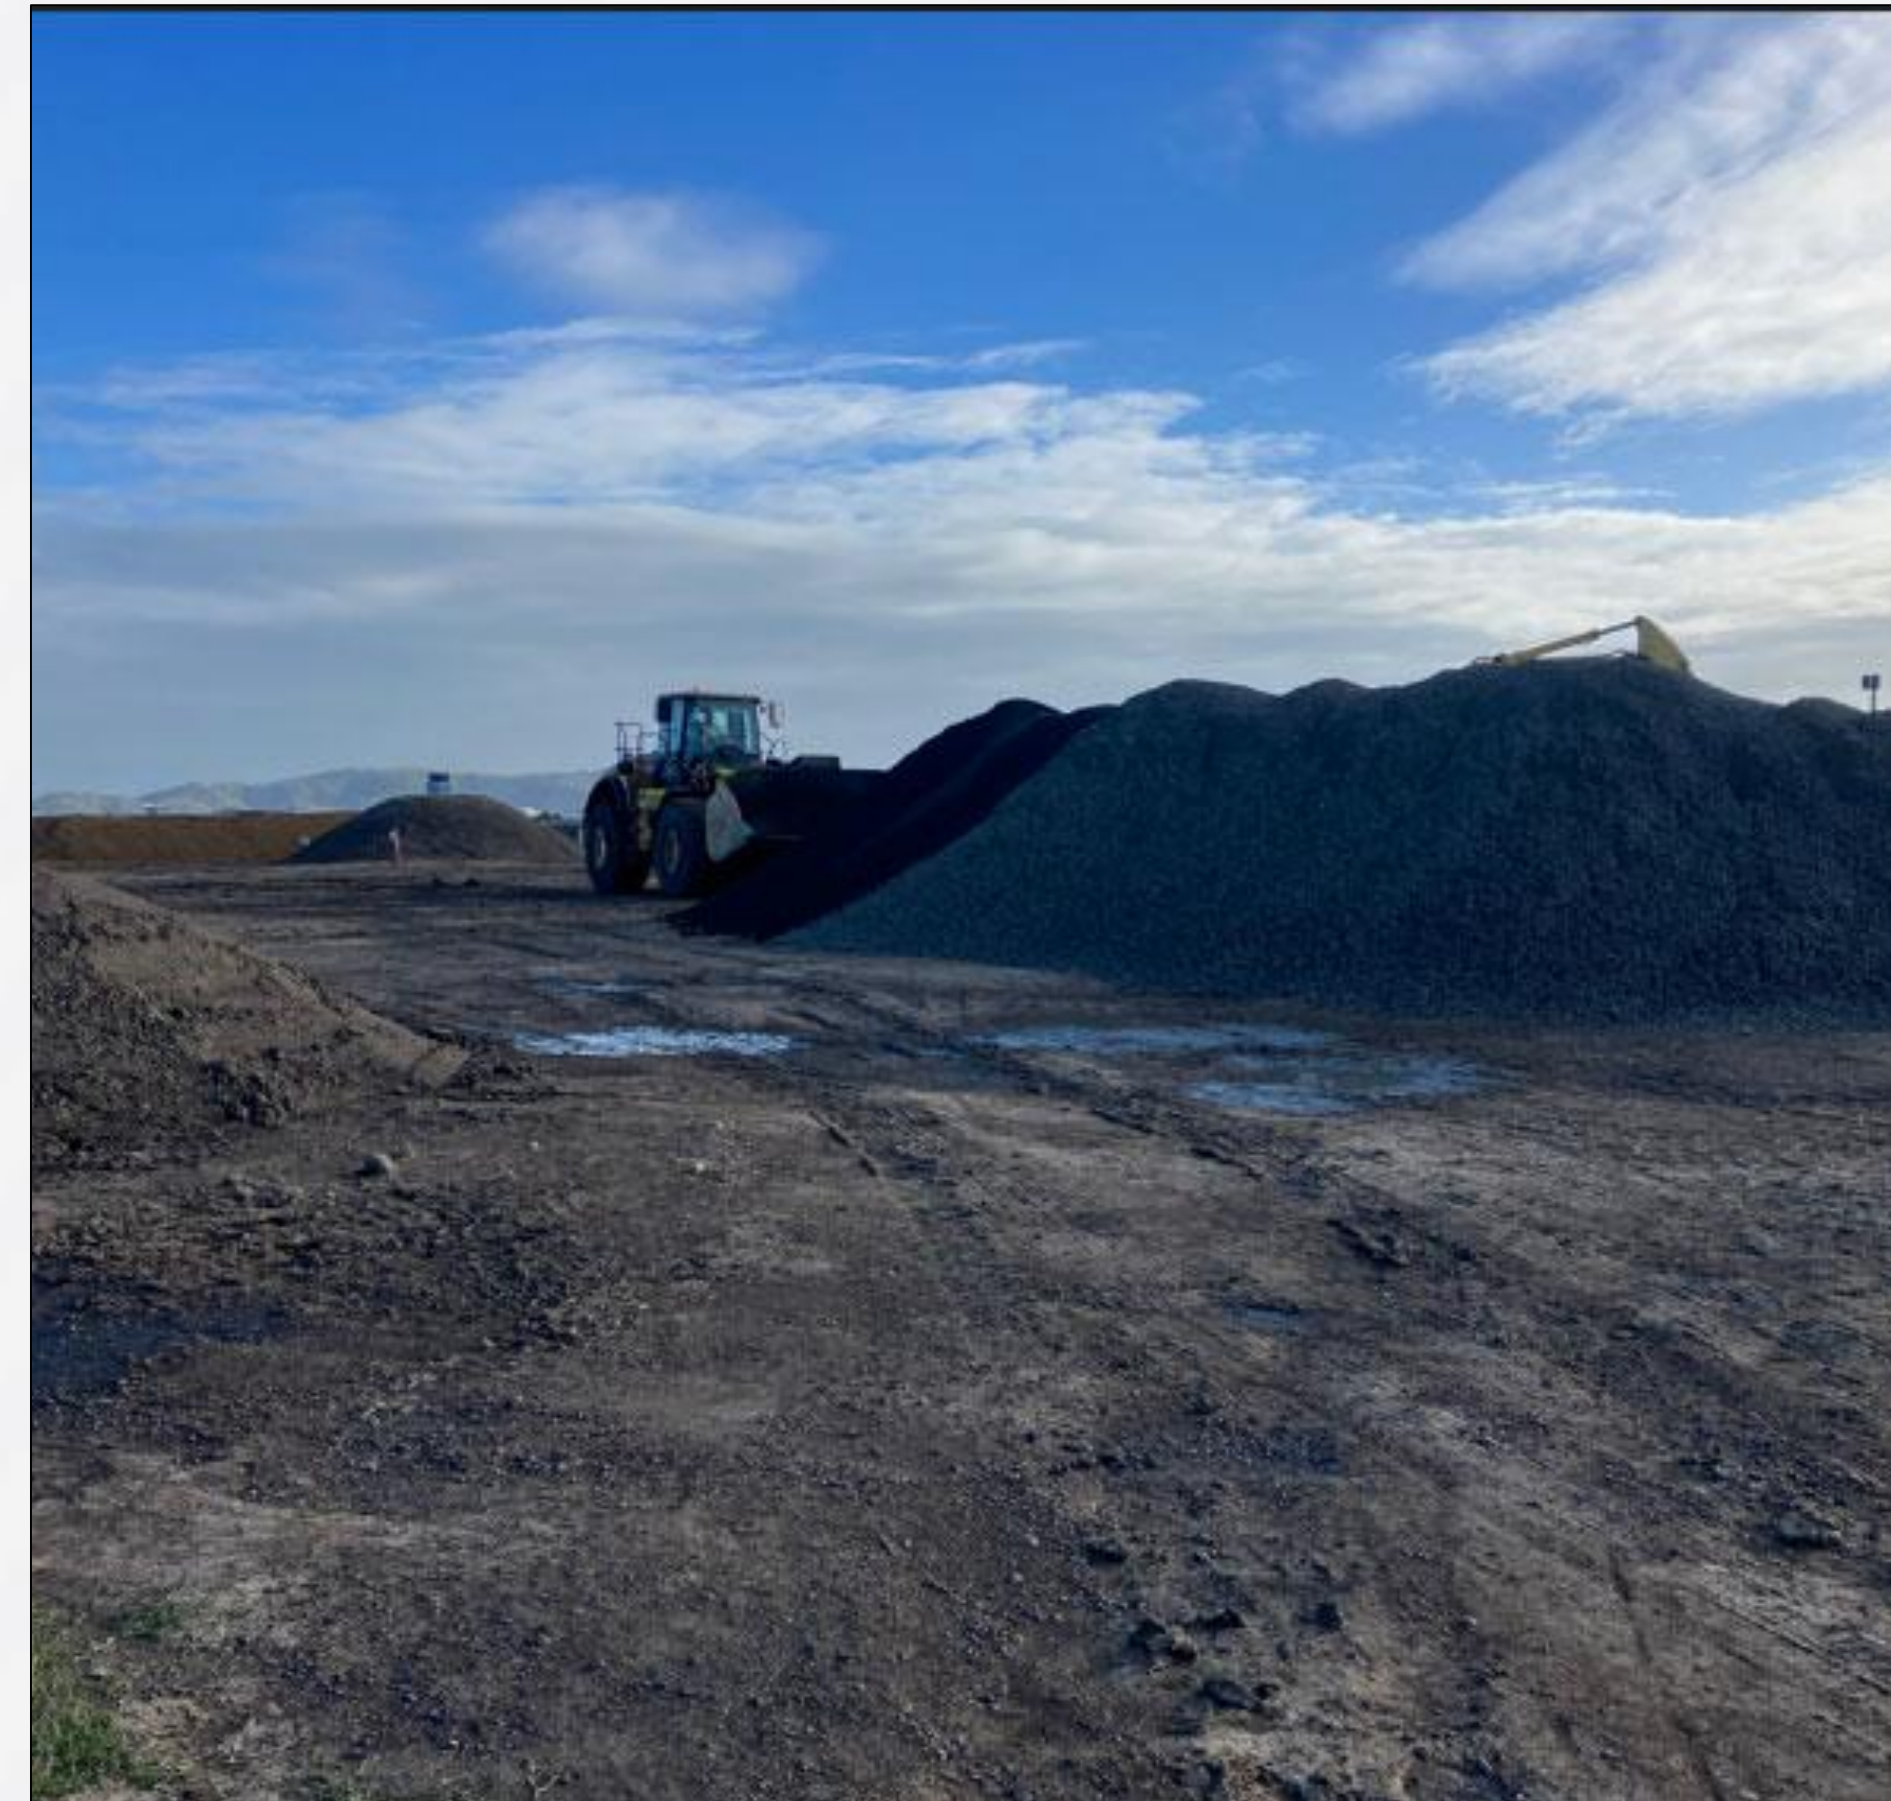
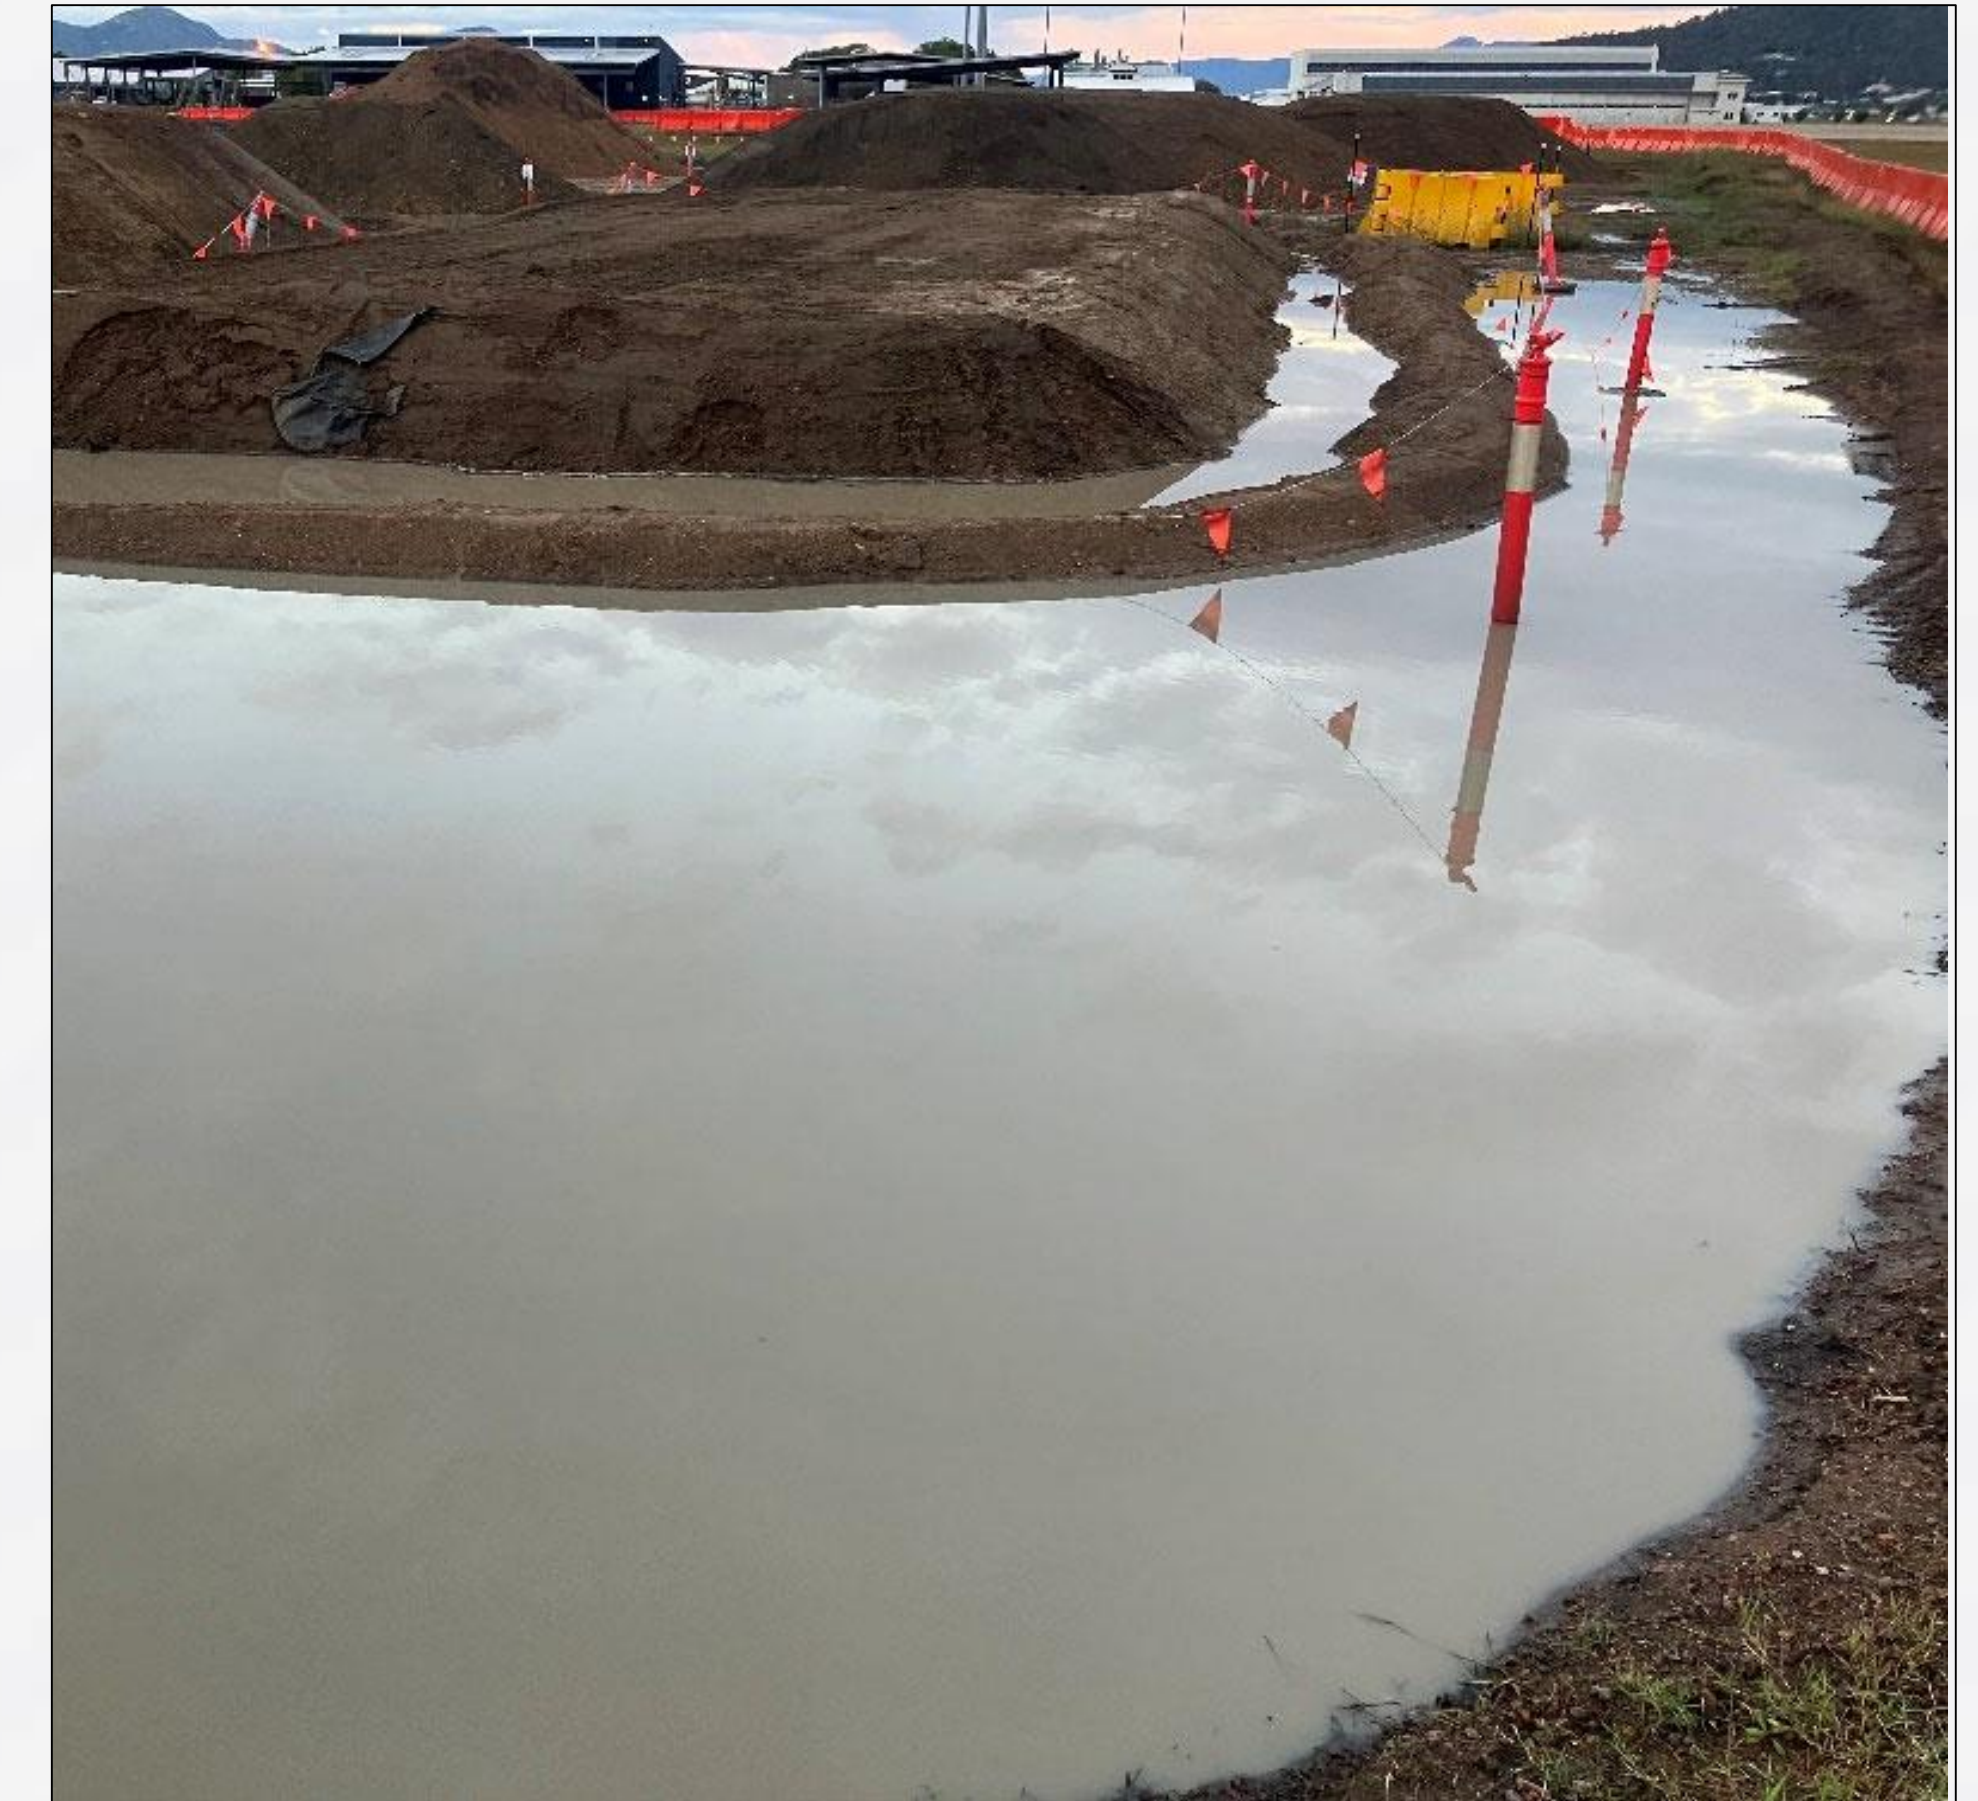
Soil remediation at the Former Fire Training Ground

7,500 m³ of soil
excavated for treatment,
or destruction off base.

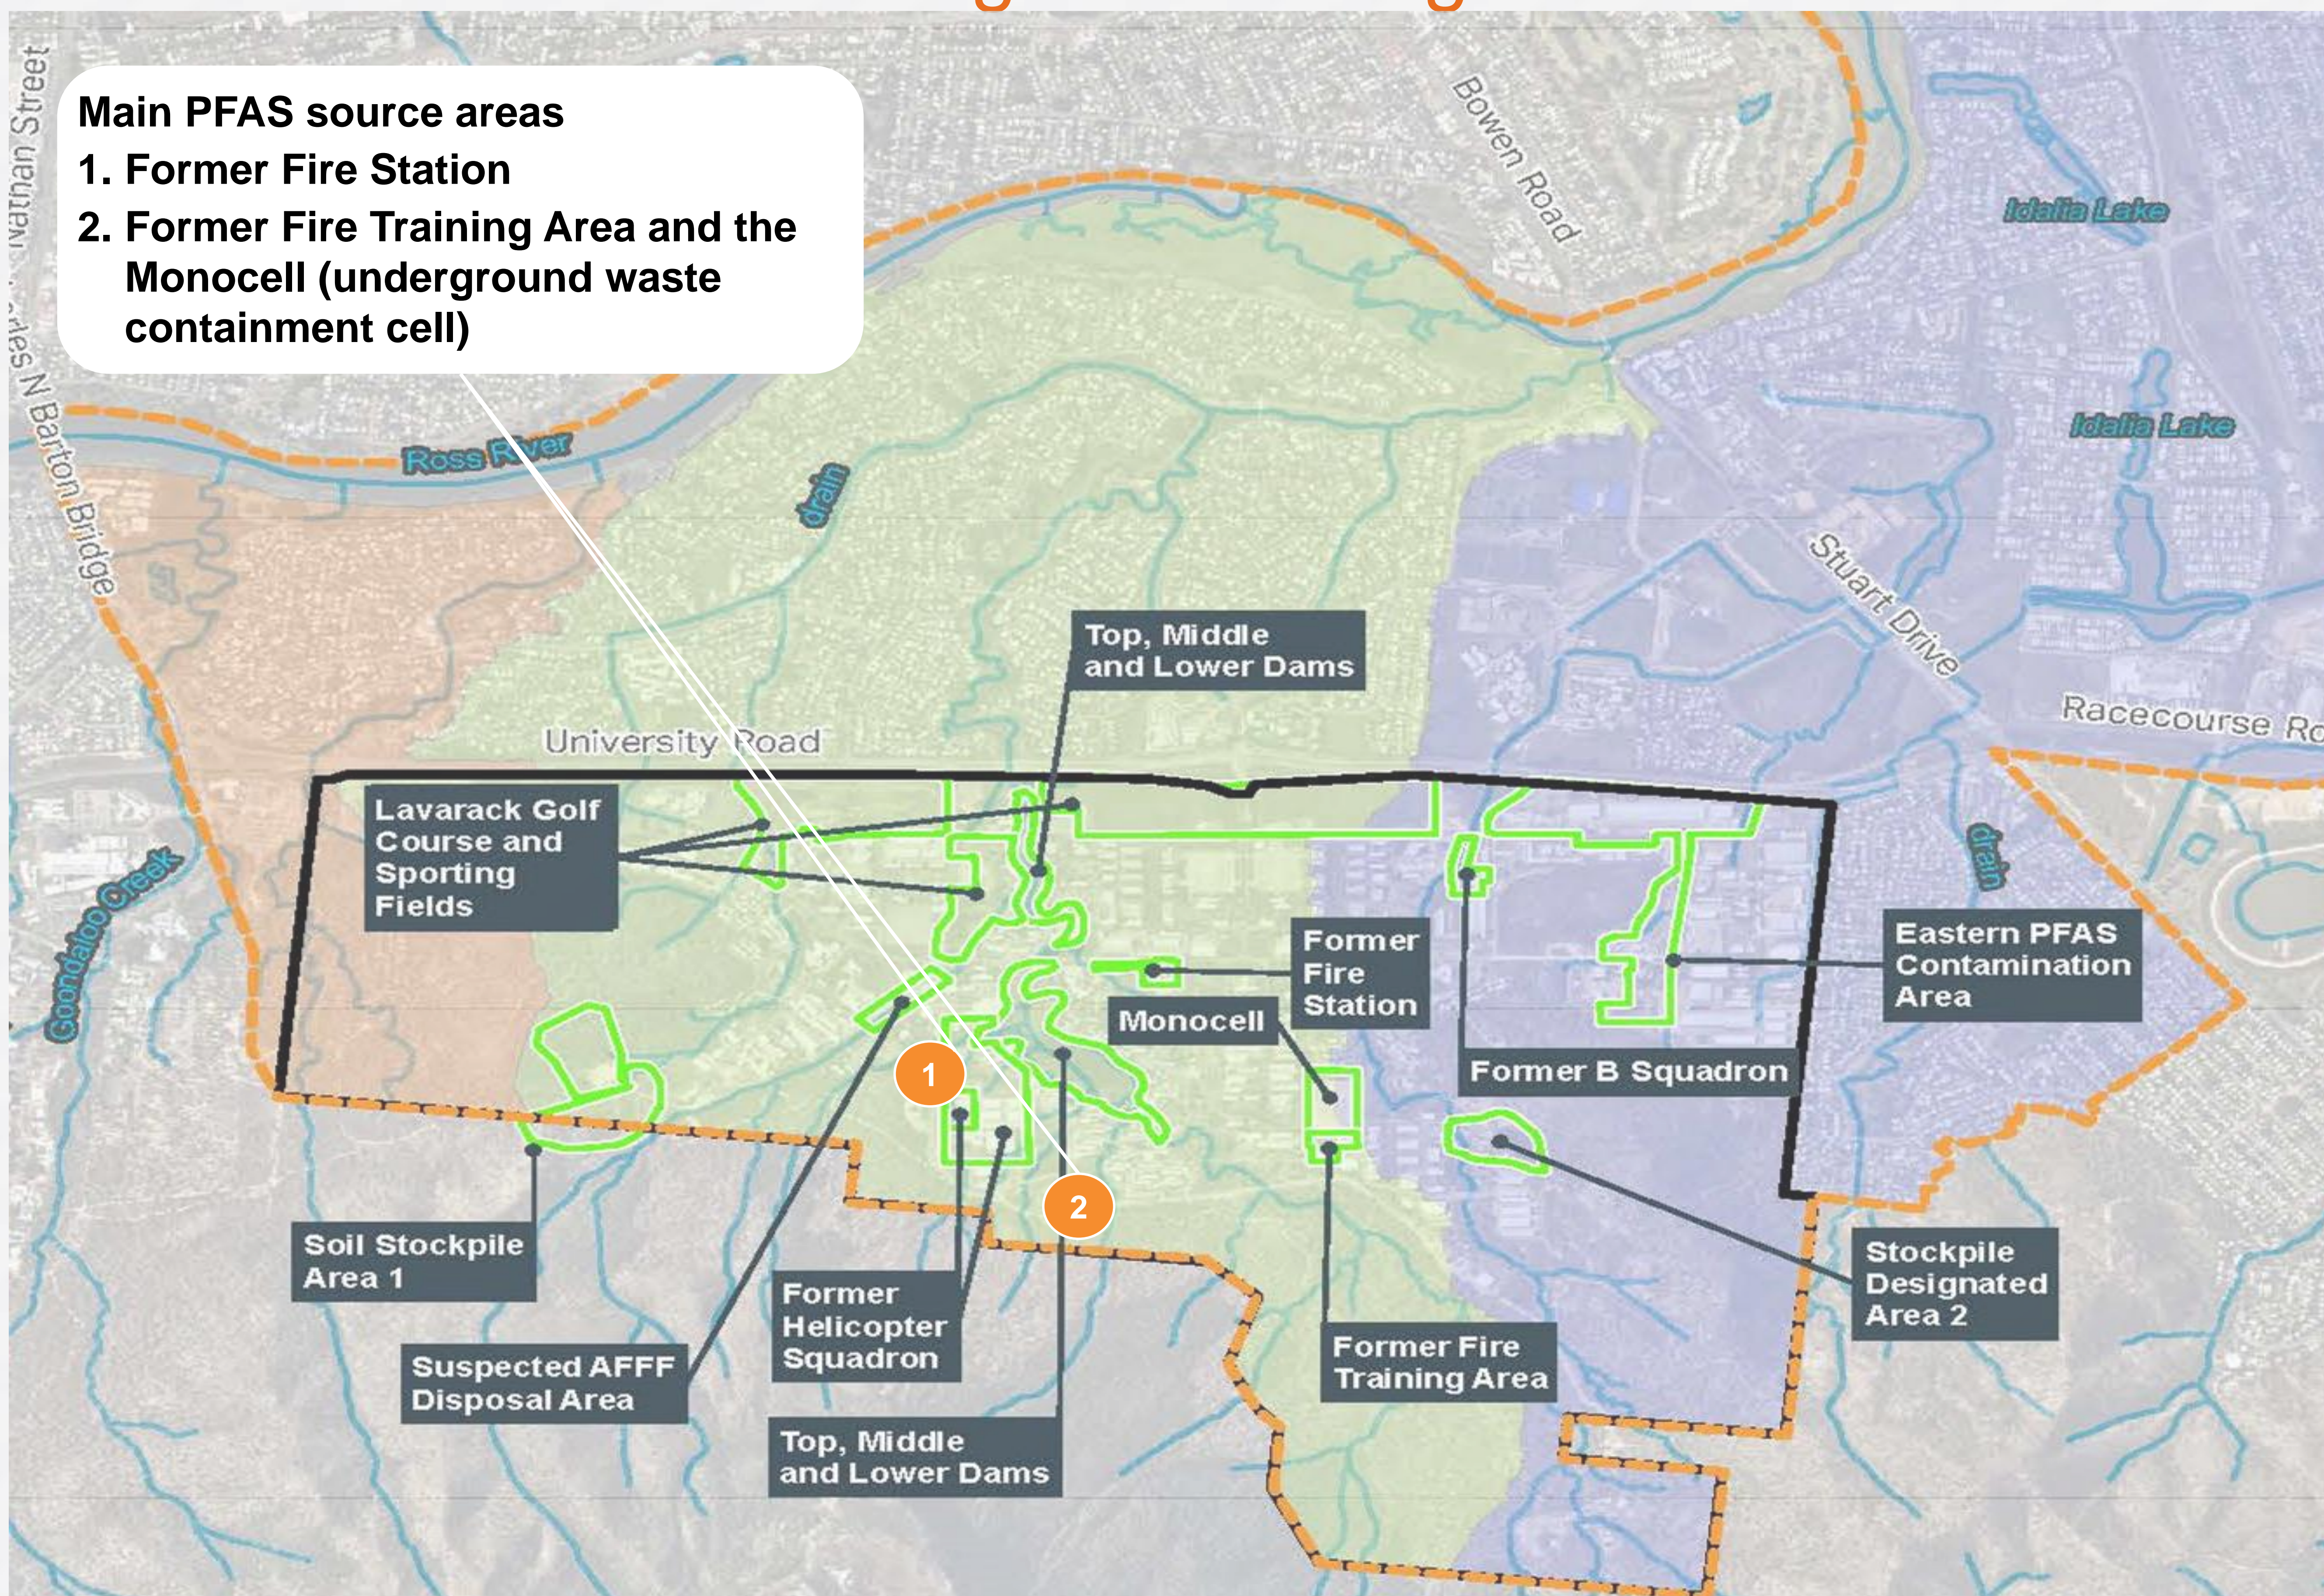
Lavarack Barracks investigation findings

1. Former Fire Station
2. Former Fire Training Area and the Monocell (underground waste containment cell)

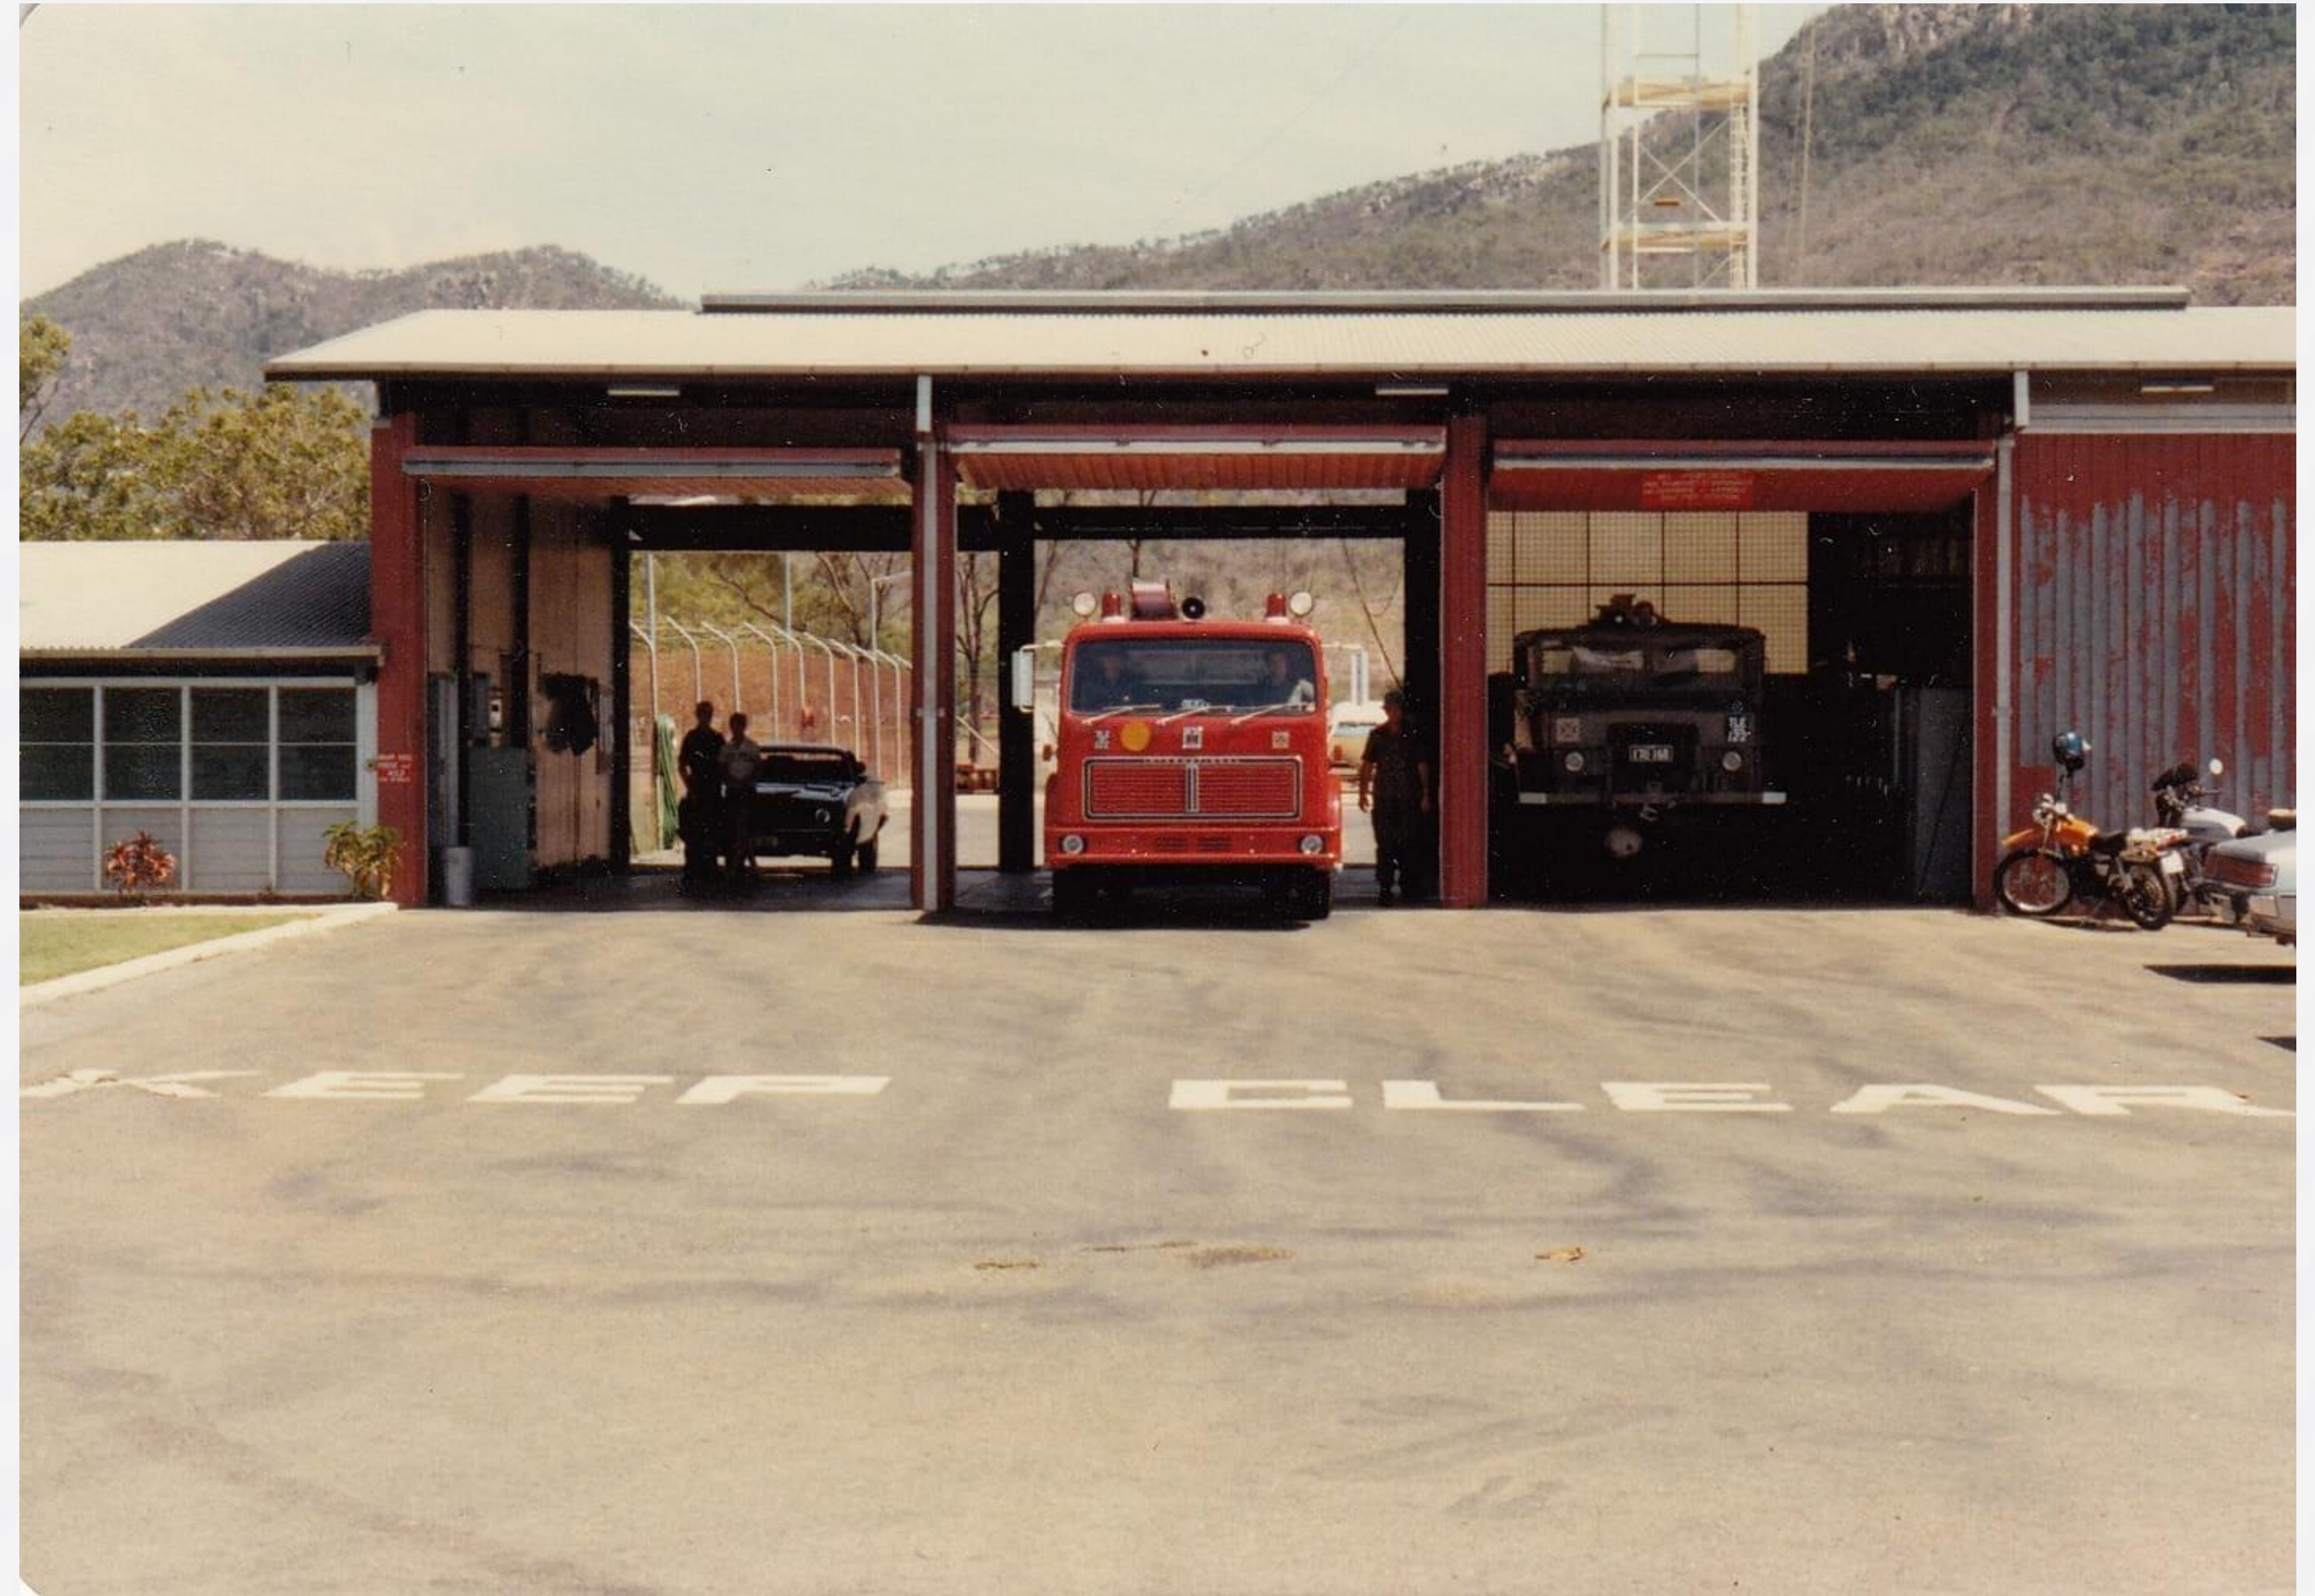
Proposed remediation at the Former Fire Station

3,100 m³ of soil to be treated or removed for thermal destruction.
