## Management area and source areas

## Remediation at RAAF Base Amberley – a multi phased approach

## Remediation and PFAS management activities

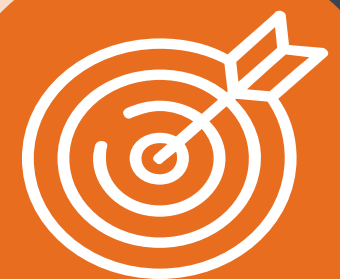
Remediation of source areas aims to reduce PFAS leaving the base.

Defence is developing remediation action plans for three major surface water catchment areas.

Remedial works will be completed progressively through to 2028.

Ongoing monitoring will continue throughout, and beyond the remediation period.
