HMAS Albatross

November 2023 – Remediation and monitoring update

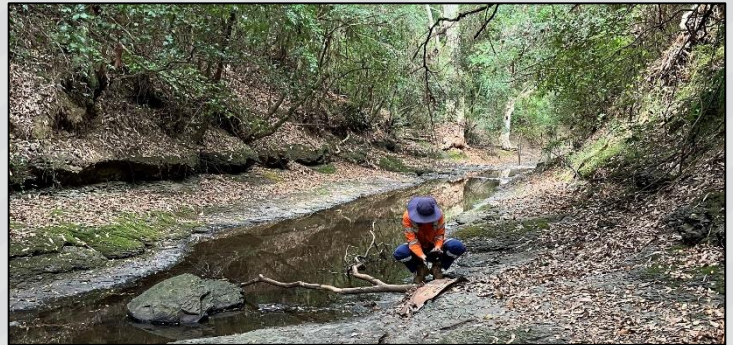
Surface water sampling being undertaken off base.

Ongoing monitoring at HMAS Albatross and within the management area occurs every February and August. Every February, 28 groundwater and 13 surface water samples are collected. Each August, 13 surface water samples are collected.

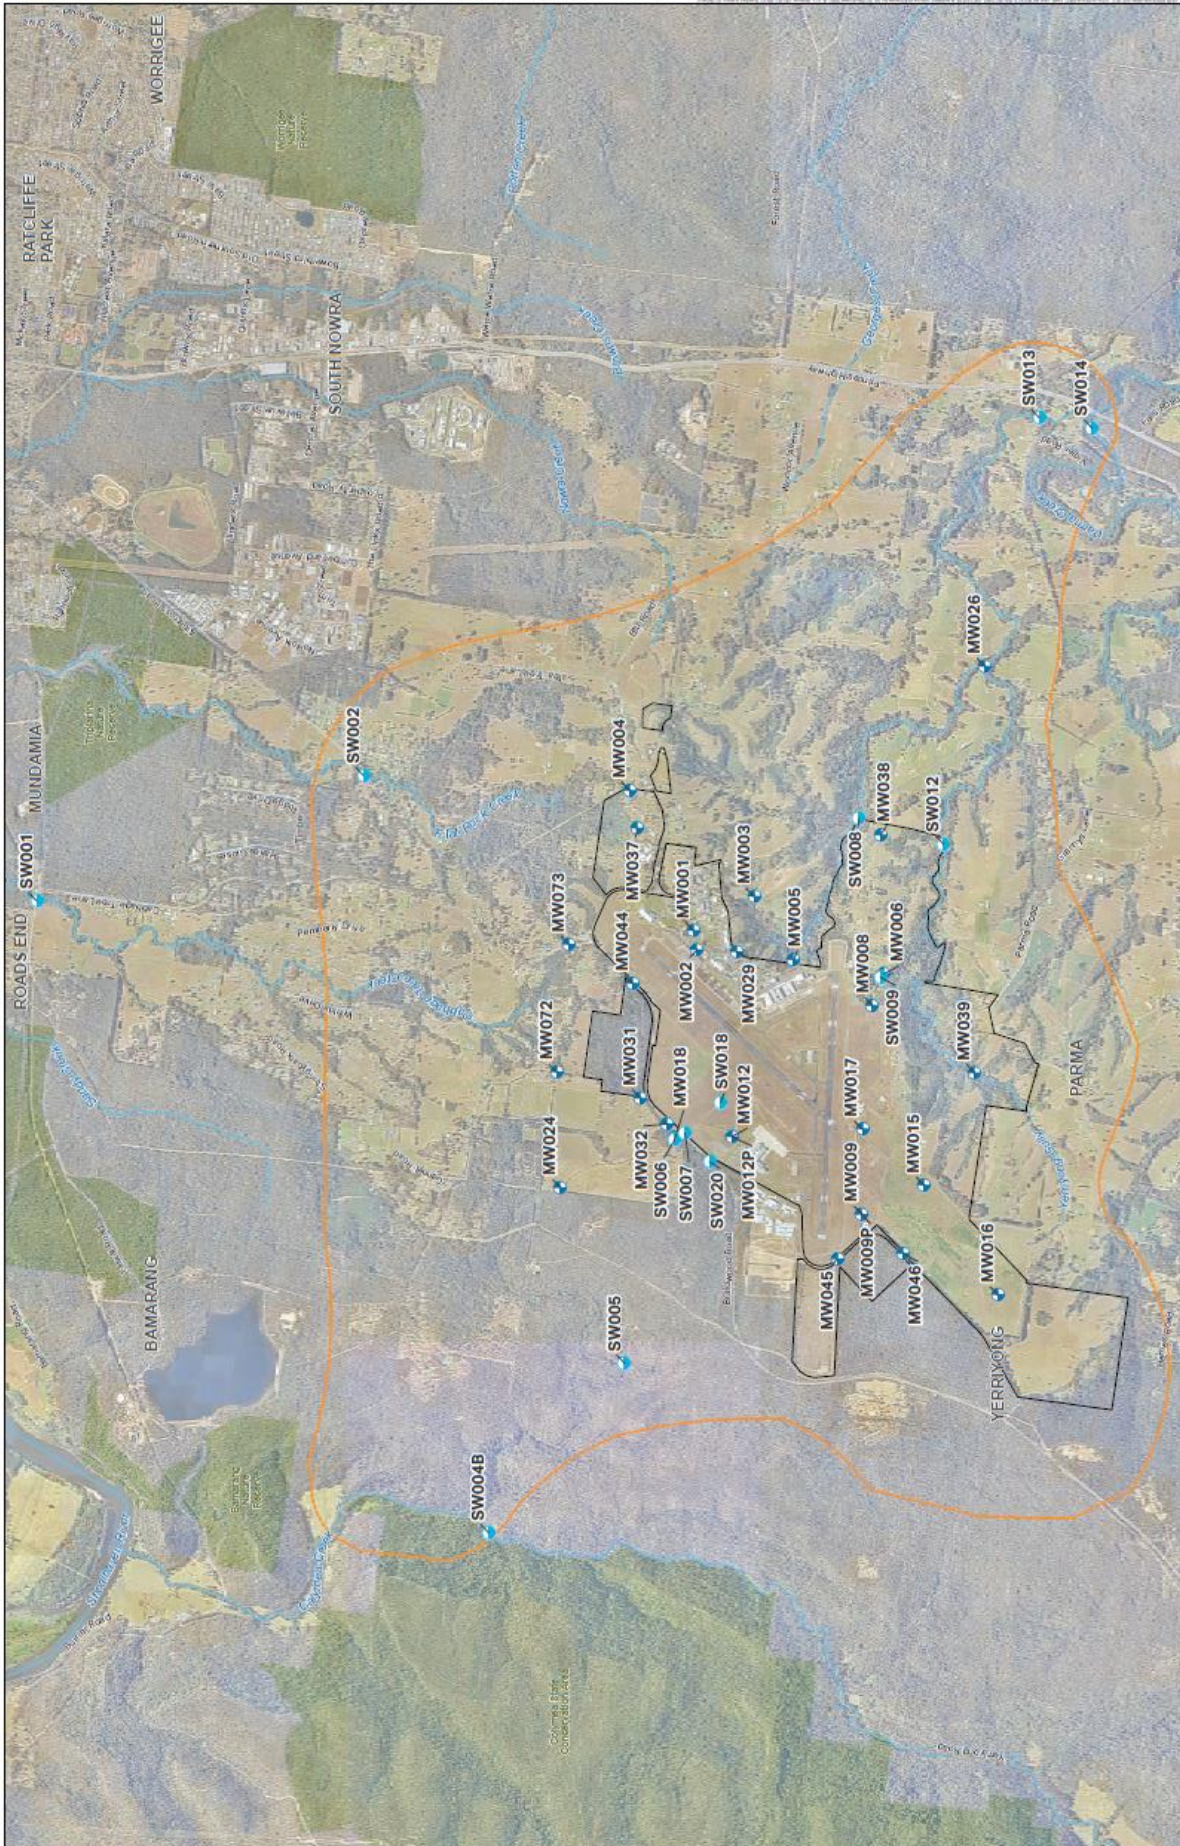
HMAS Albatross Monitoring Locations

OMP SAMPLE LOCATIONS
